Heritage Orangeville Committee Meeting

Thursday, May 13, 2021, 7:00 p.m.

1. Call to Order
2. Disclosures of (Direct or Indirect) Pecuniary Interest
3. Adoption of Minutes of Previous Meeting - Not Applicable
4. Presentations
5. Items for Discussion and Reports
 - 5.1. Comments from Bruce Ewald, Chief Building Inspector - Demolition of Dwelling - 14 William Street
6. Facade Improvement Applications
7. Correspondence
8. New Business
9. Date of Next Meeting

14 William St Orangeville Demolition permit application:

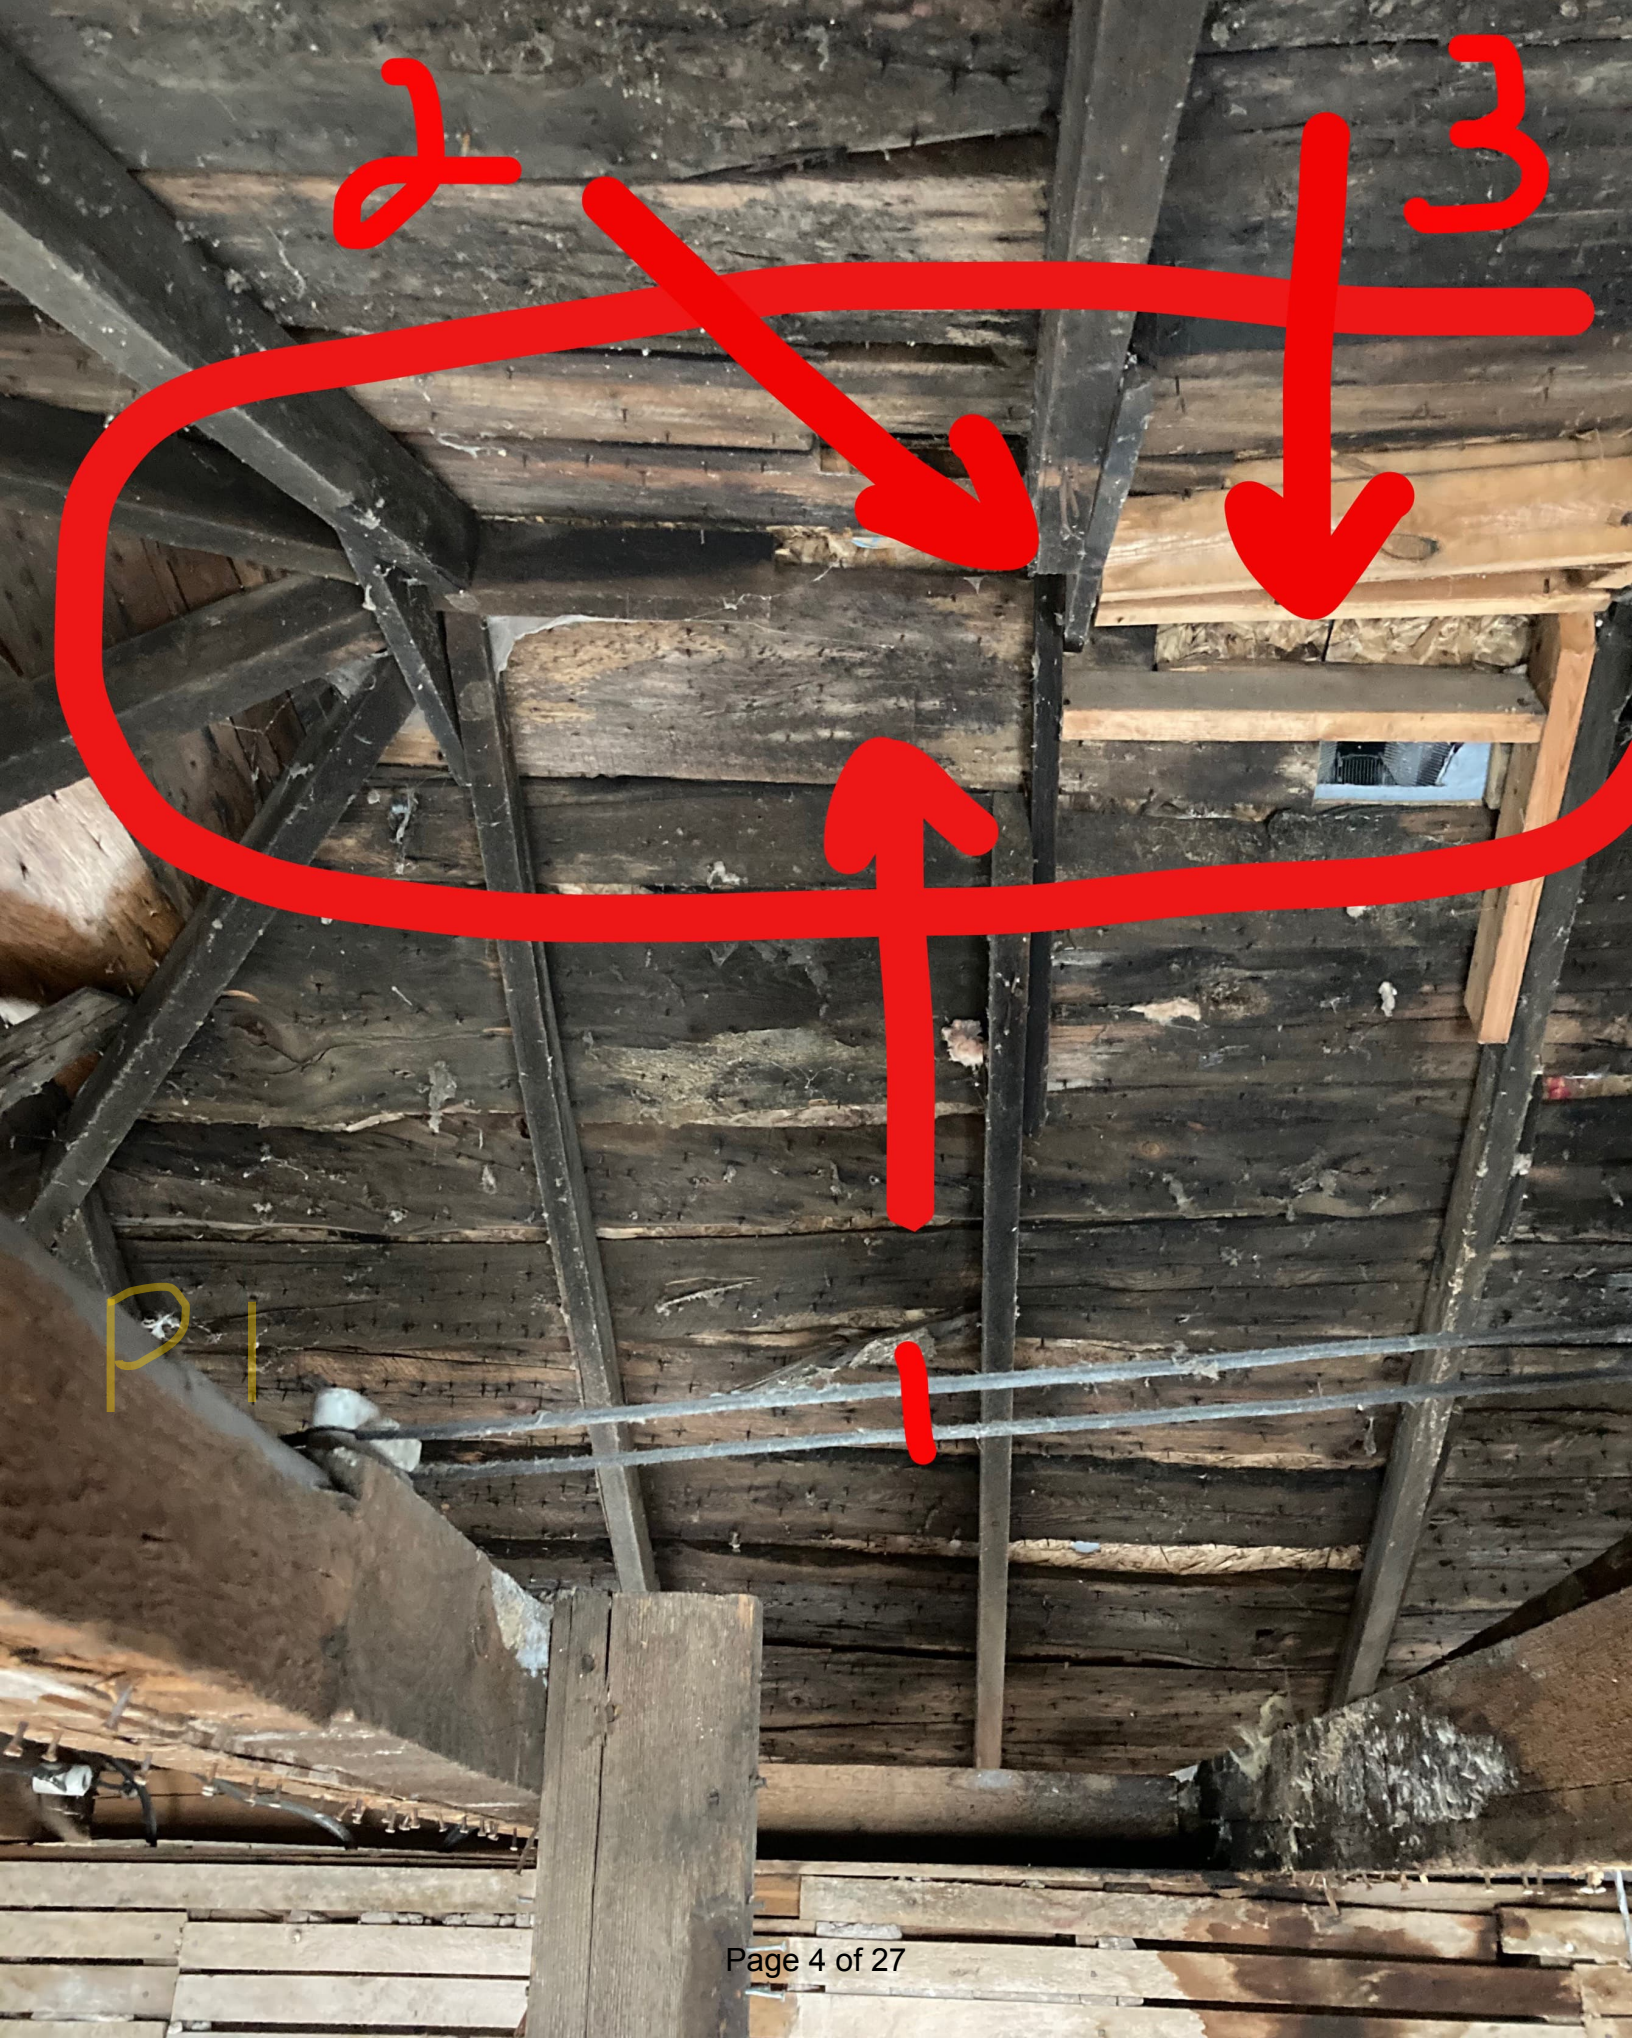
Pic	Issue
1.1	Missing ridge board (left side). Ridge structurally unsound and sagged
1.2	Spliced rafter with 1x4
1.3	Spliced board onto 1x4
2	Missing pieces of ridge board (right side) and partially scabbed together.

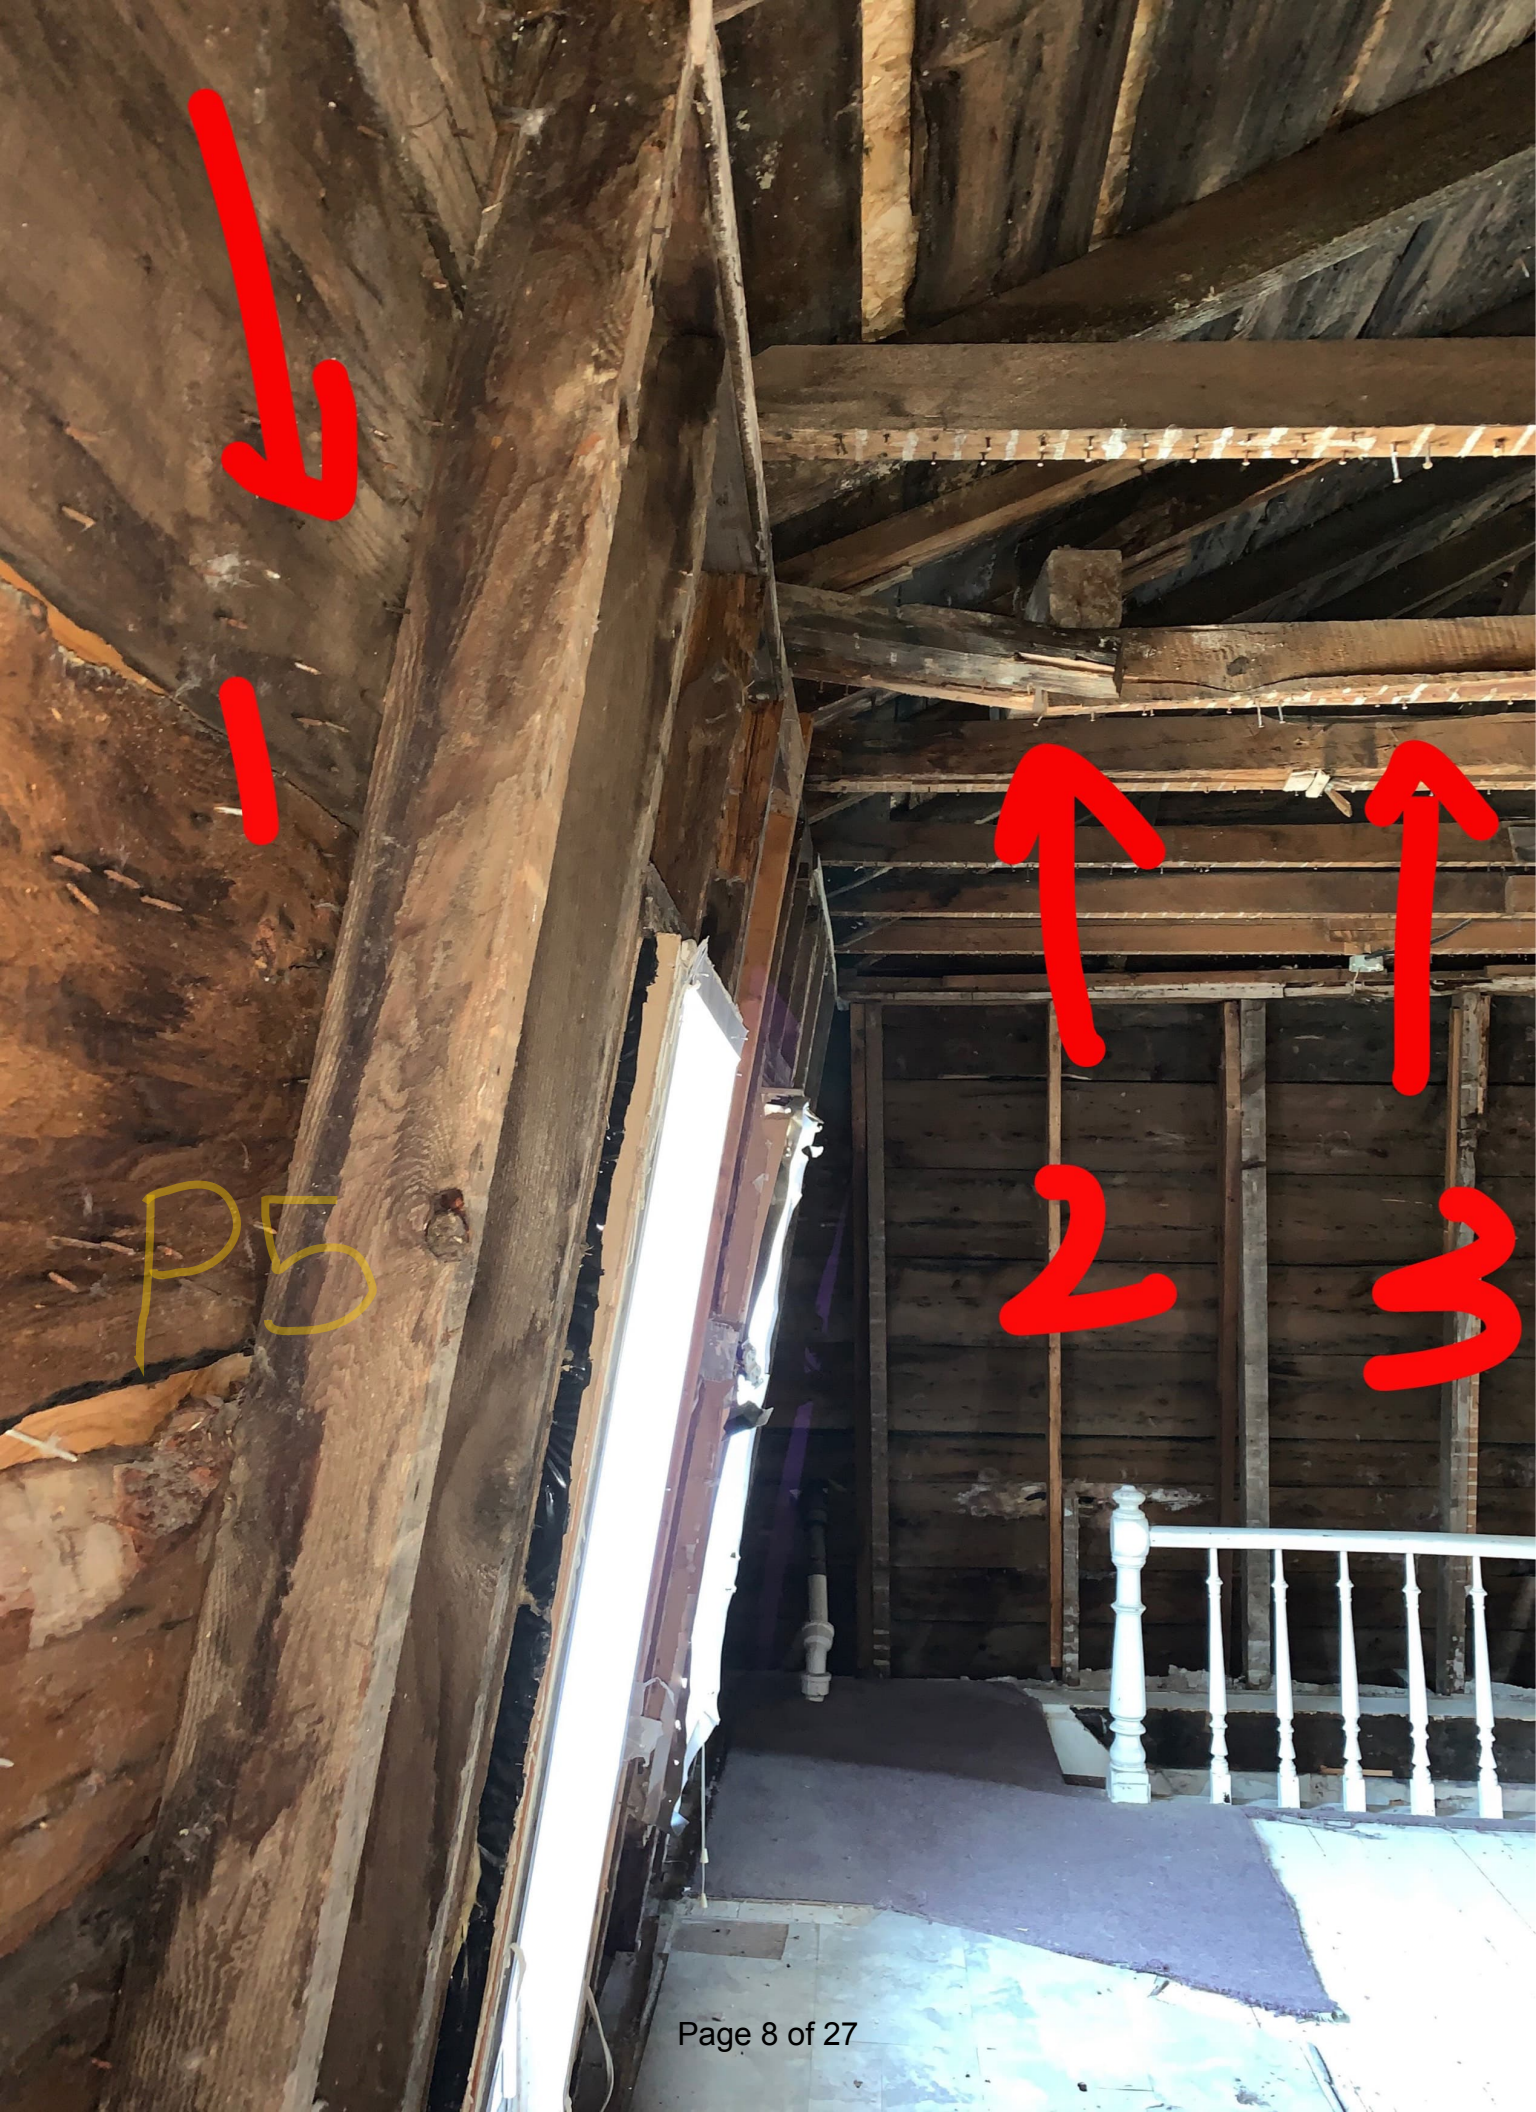
P5

5.1	Supporting mansard rafters are on angles, scabbed together and some have rot
5.2	Ceiling joists are snapped, scabbed together
5.3	Ceiling joist snapped

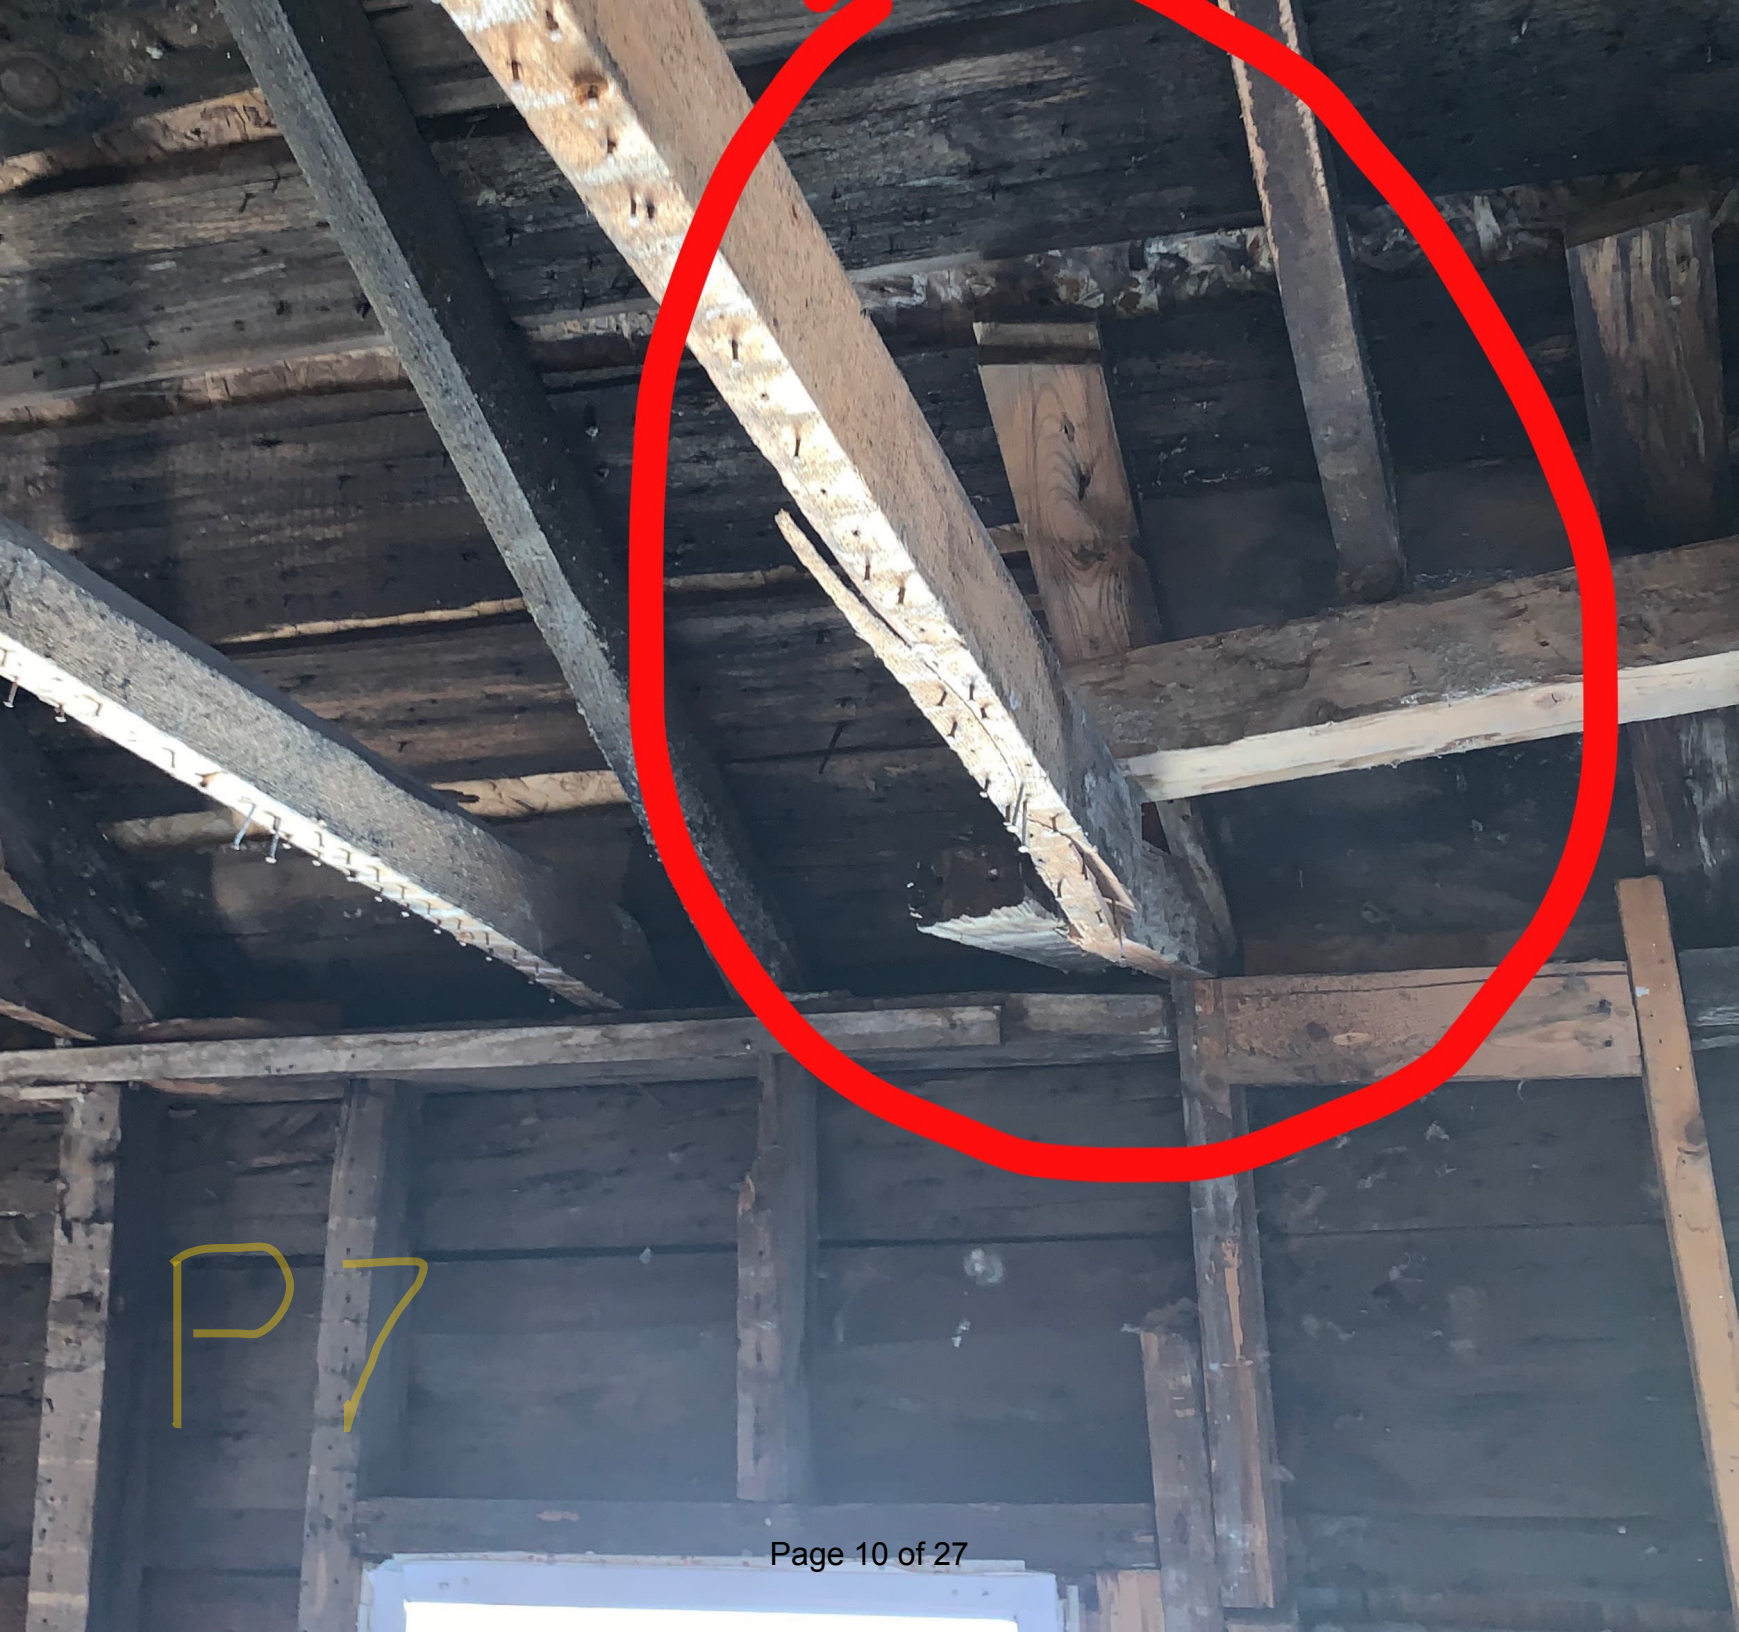
P7

6.1-6.4	Another view of ceiling and mansard rafters
7	Scabbed together ceiling joist with crack
8.1	Ceiling joist with water damage
8.2-8.3	Scissored ceiling joist, doesn't run entire ceiling width

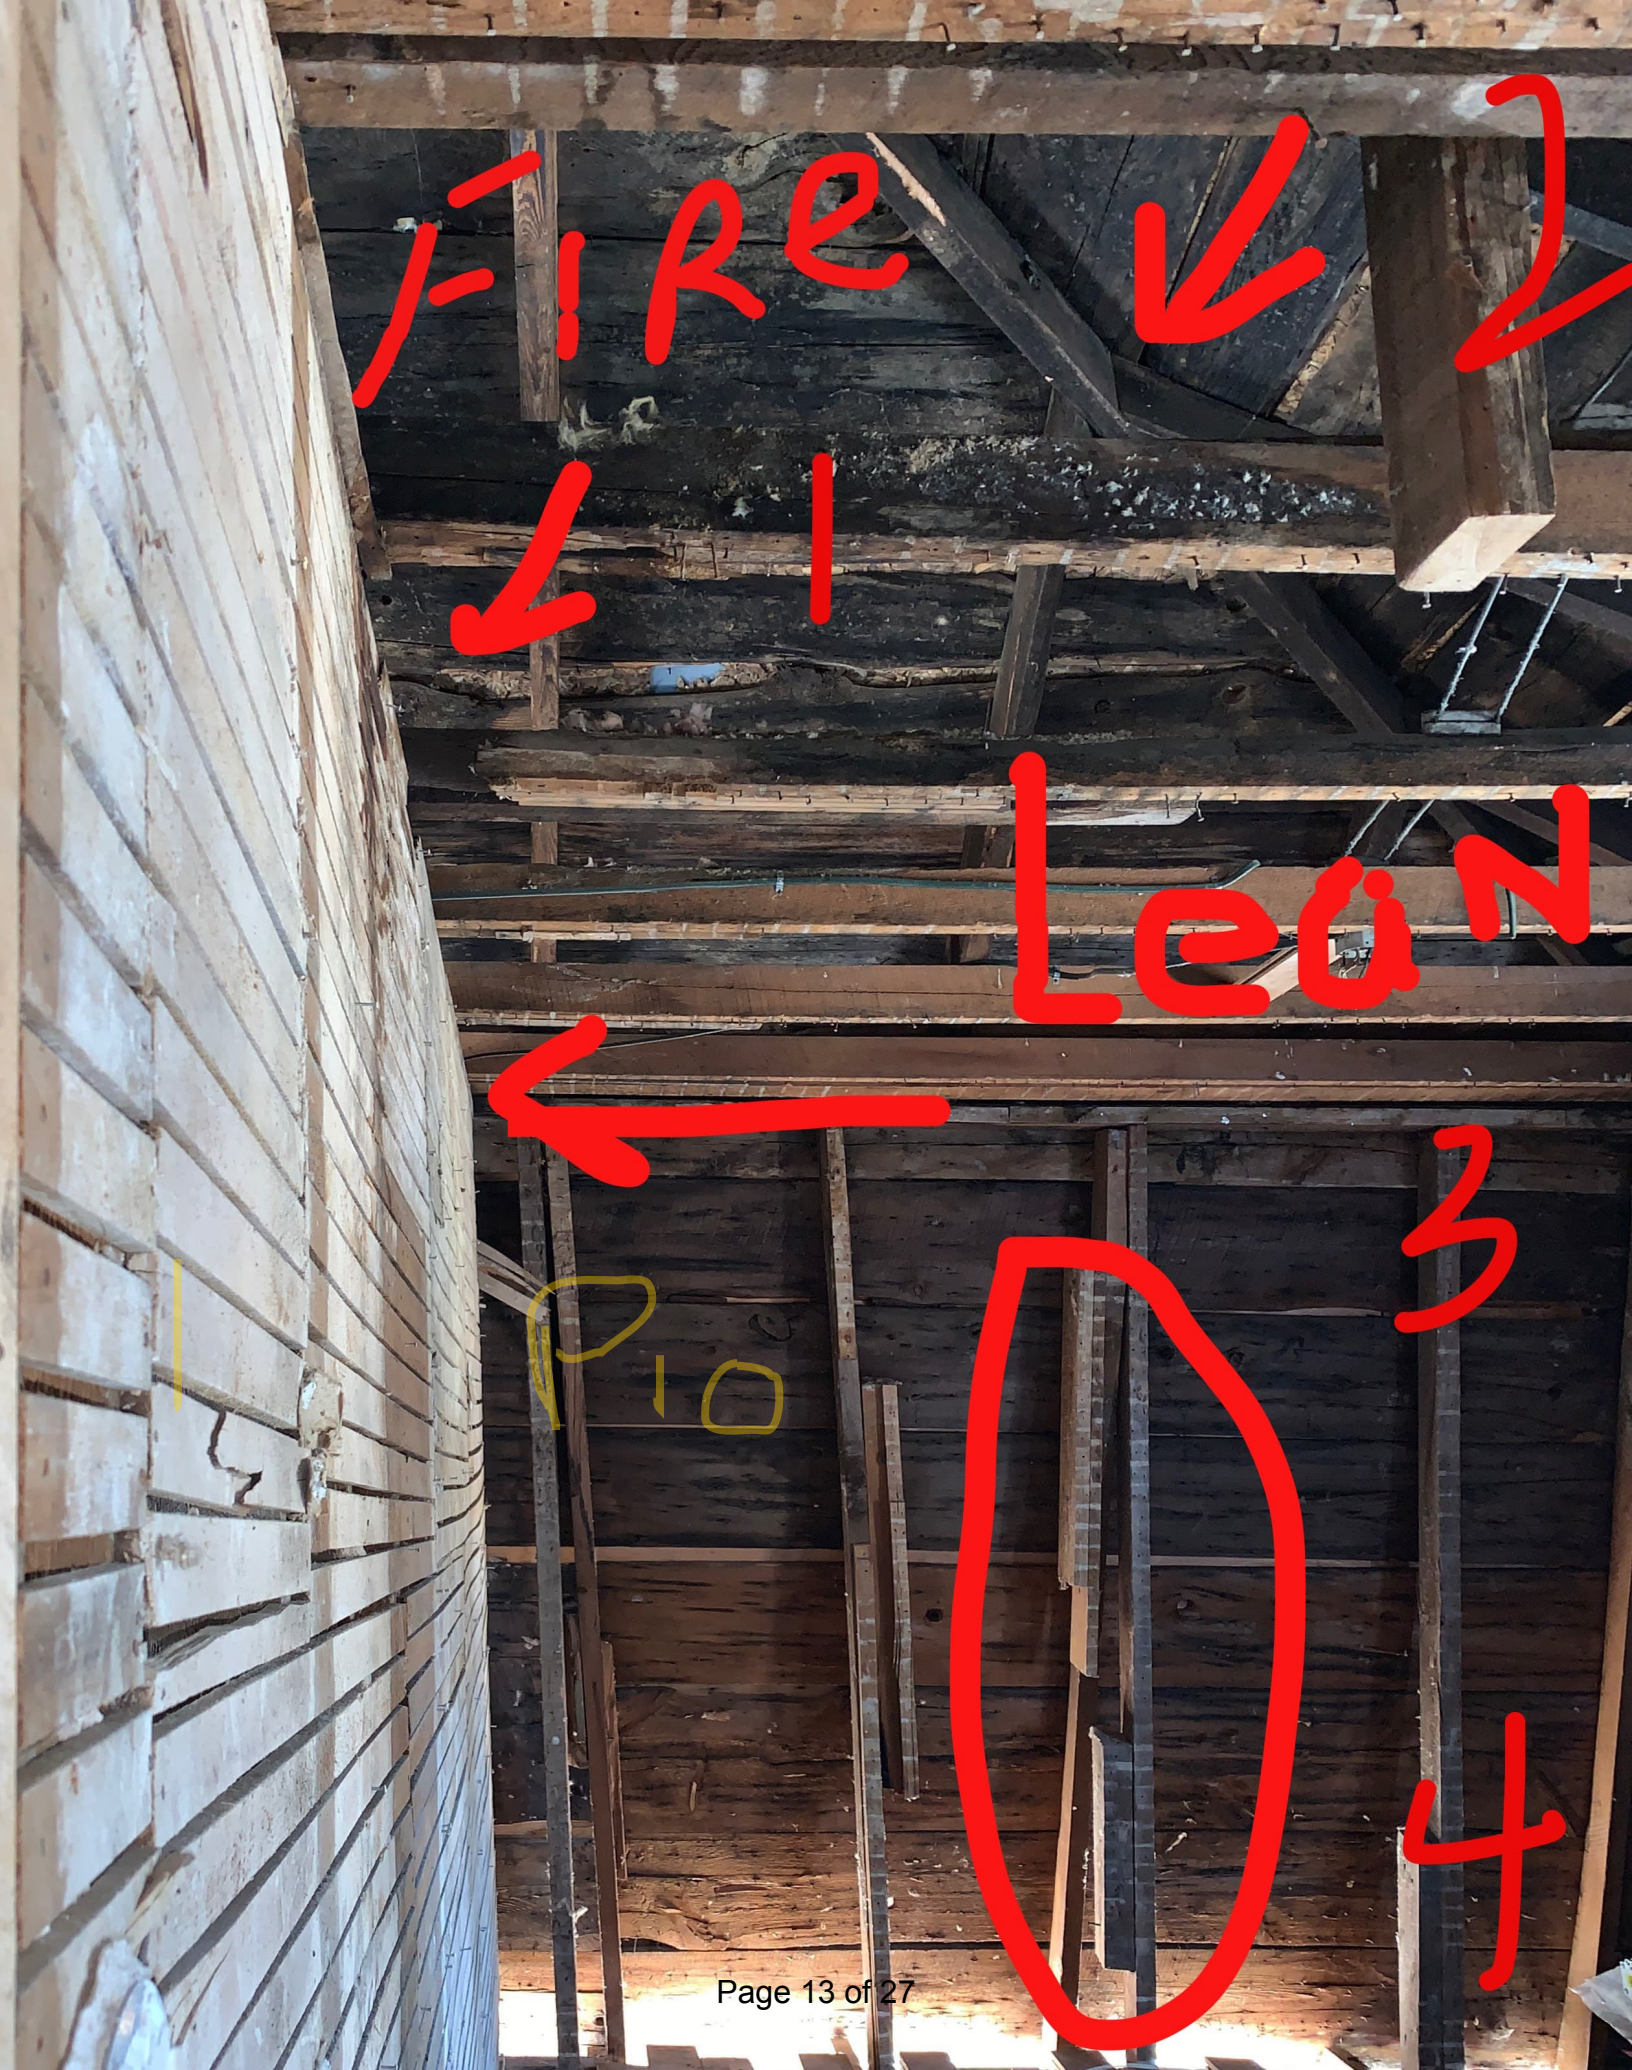
P10

9.1	Original sheathing on roof has wood rot and is falling apart, exposing shingles
9.2	Wall sheathing is crumbling on touch
10.1	Fire damage
10.2	Water damage and rot

10.3	Bearing wall has shifted and leans
10.4	Mansard rafters/walls scabbed together
11	Structural- Bearing wall had previous fire, both plates have been burned through and the ceiling joist

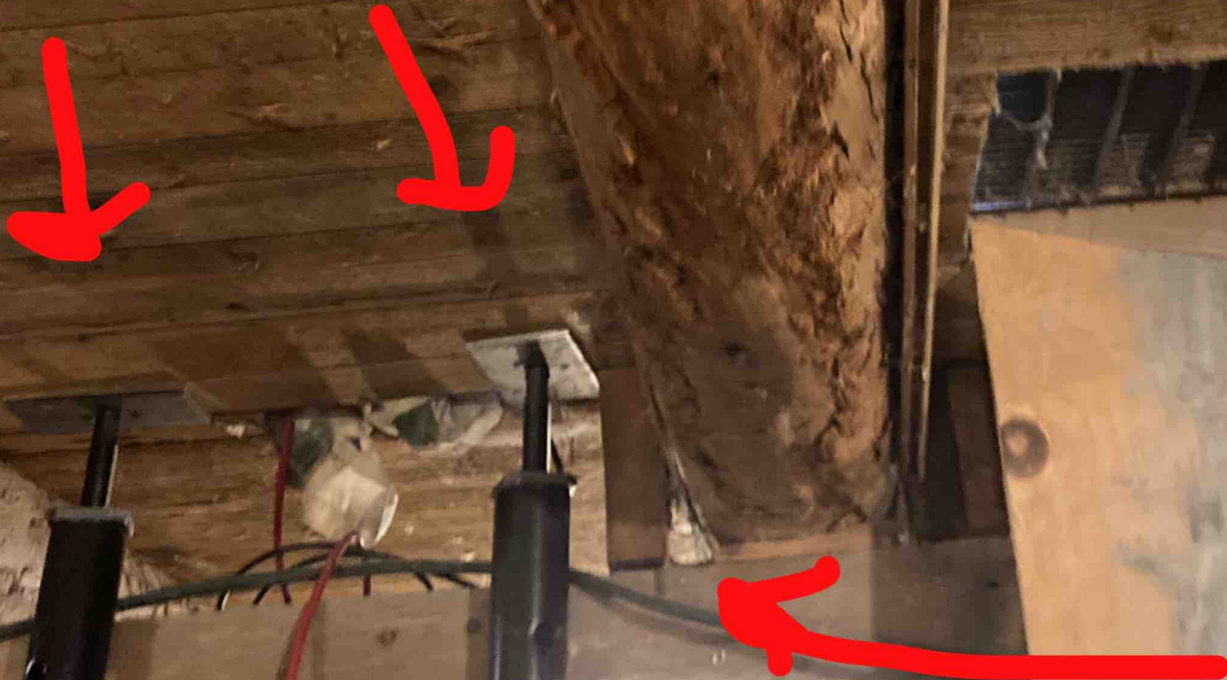
P21

19.1-19.3 -20	Floor joists on first floor (numbered) are made of logs and full of dry rot. Crumble to the touch.
21.1-21.2	Center weight bearing wall running up to second floor has sagged and is compromised as the main beam in the basement is not supported correctly and the support post has rot due to water
22	We added temporary jack posts as the main beam is crooked and not under the weight bearing wall on the 1 st floor that runs to the 2 nd floor (causing weight bearing wall on 2 nd floor to lean as the wall is not supported evenly).
