Heritage Orangeville Committee Meeting

Thursday, May 13, 2021, 7:00 p.m.

1. Call to Order
2. Disclosures of (Direct or Indirect) Pecuniary Interest
3. Adoption of Minutes of Previous Meeting - Not Applicable
4. Presentations
5. Items for Discussion and Reports
 - 5.1. Comments from Bruce Ewald, Chief Building Inspector - Demolition of Dwelling - 14 William Street
6. Facade Improvement Applications
7. Correspondence
8. New Business
9. Date of Next Meeting

14 William St Orangeville Demolition permit application:

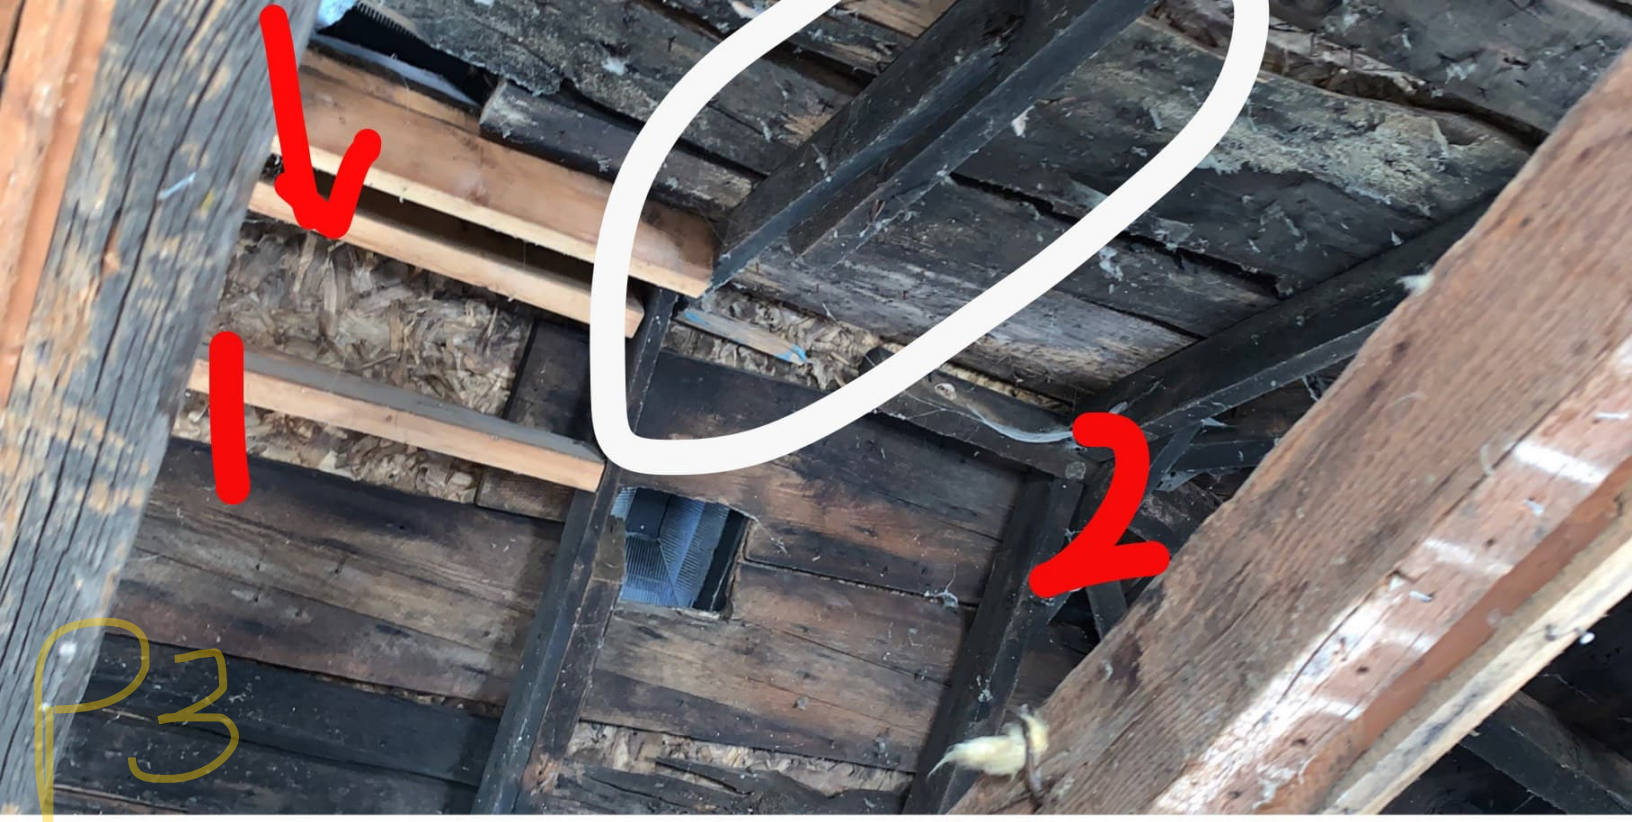
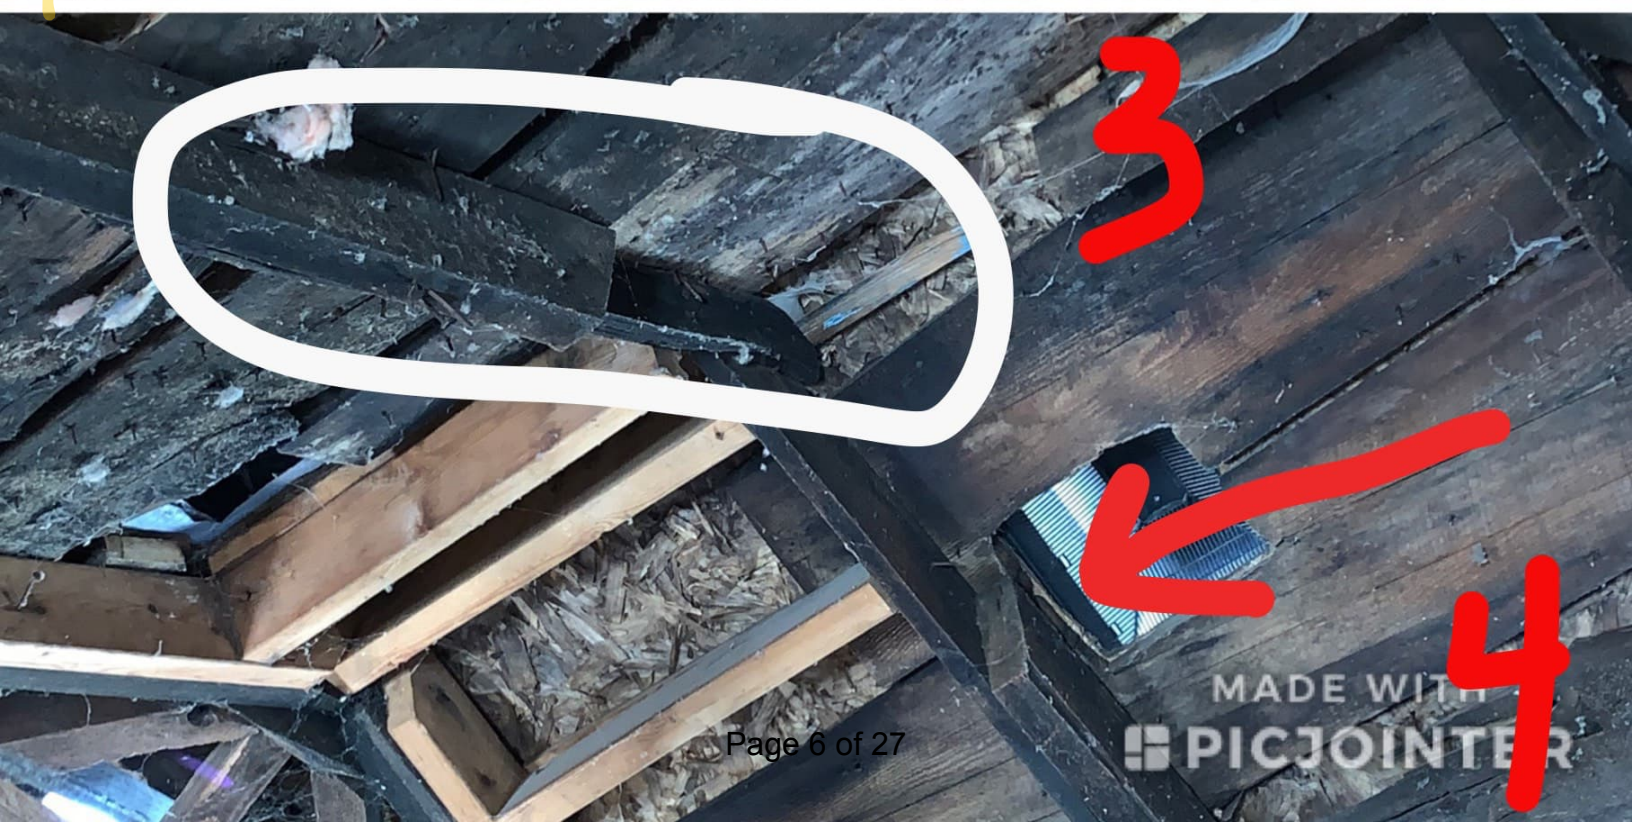
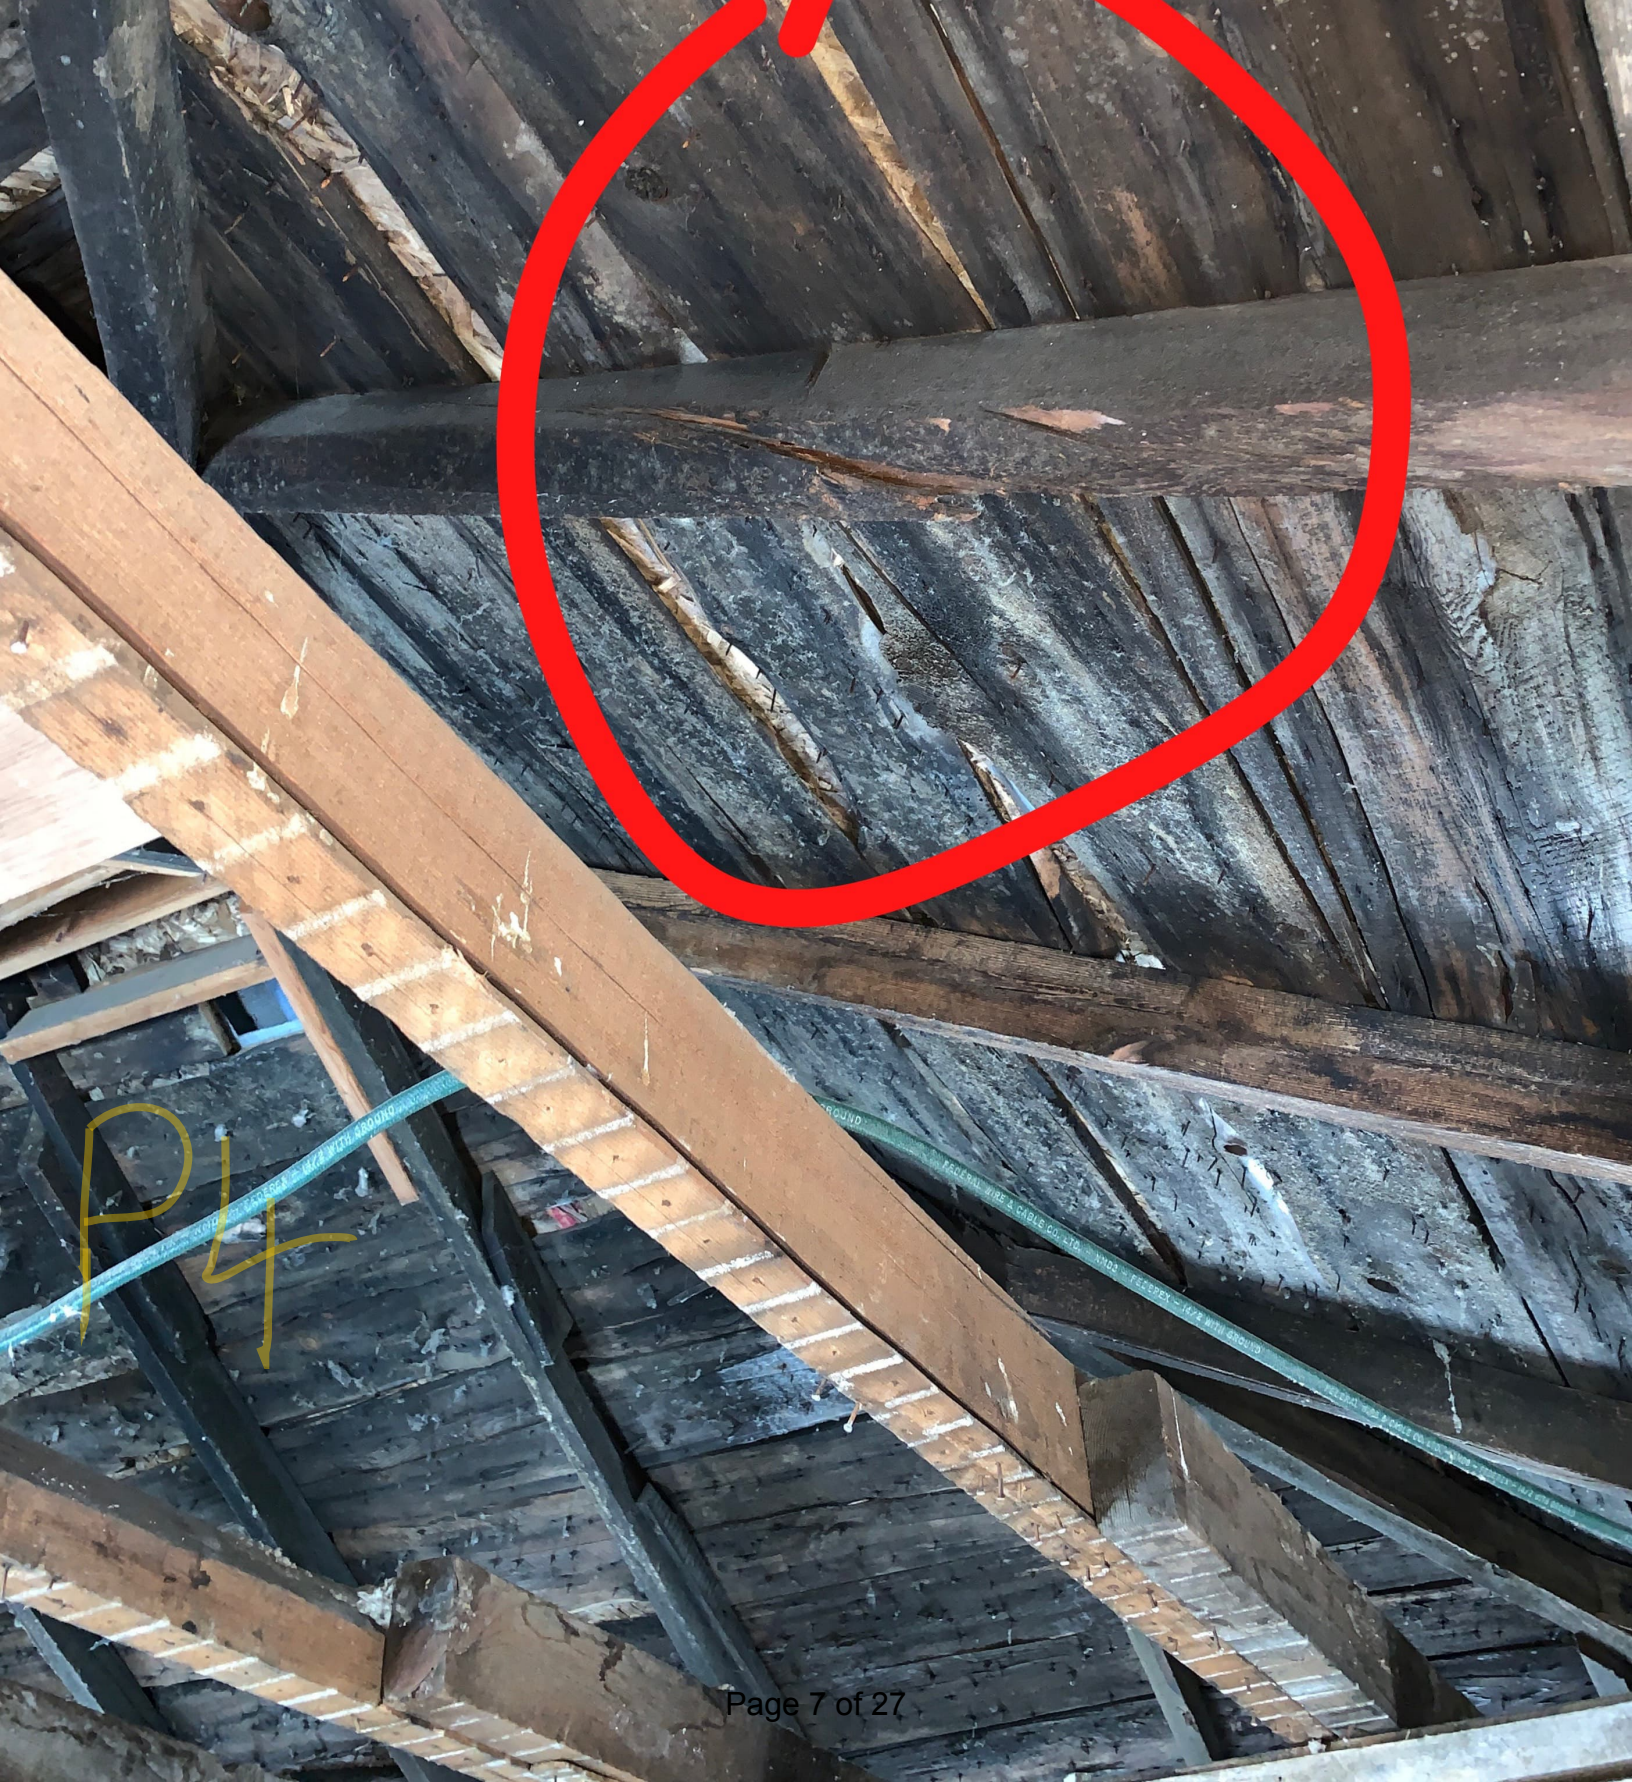
P2

Pic	Issue
1.1	Missing ridge board (left side). Ridge structurally unsound and sagged
1.2	Spliced rafter with 1x4
1.3	Spliced board onto 1x4
2	Missing pieces of ridge board (right side) and partially scabbed together.

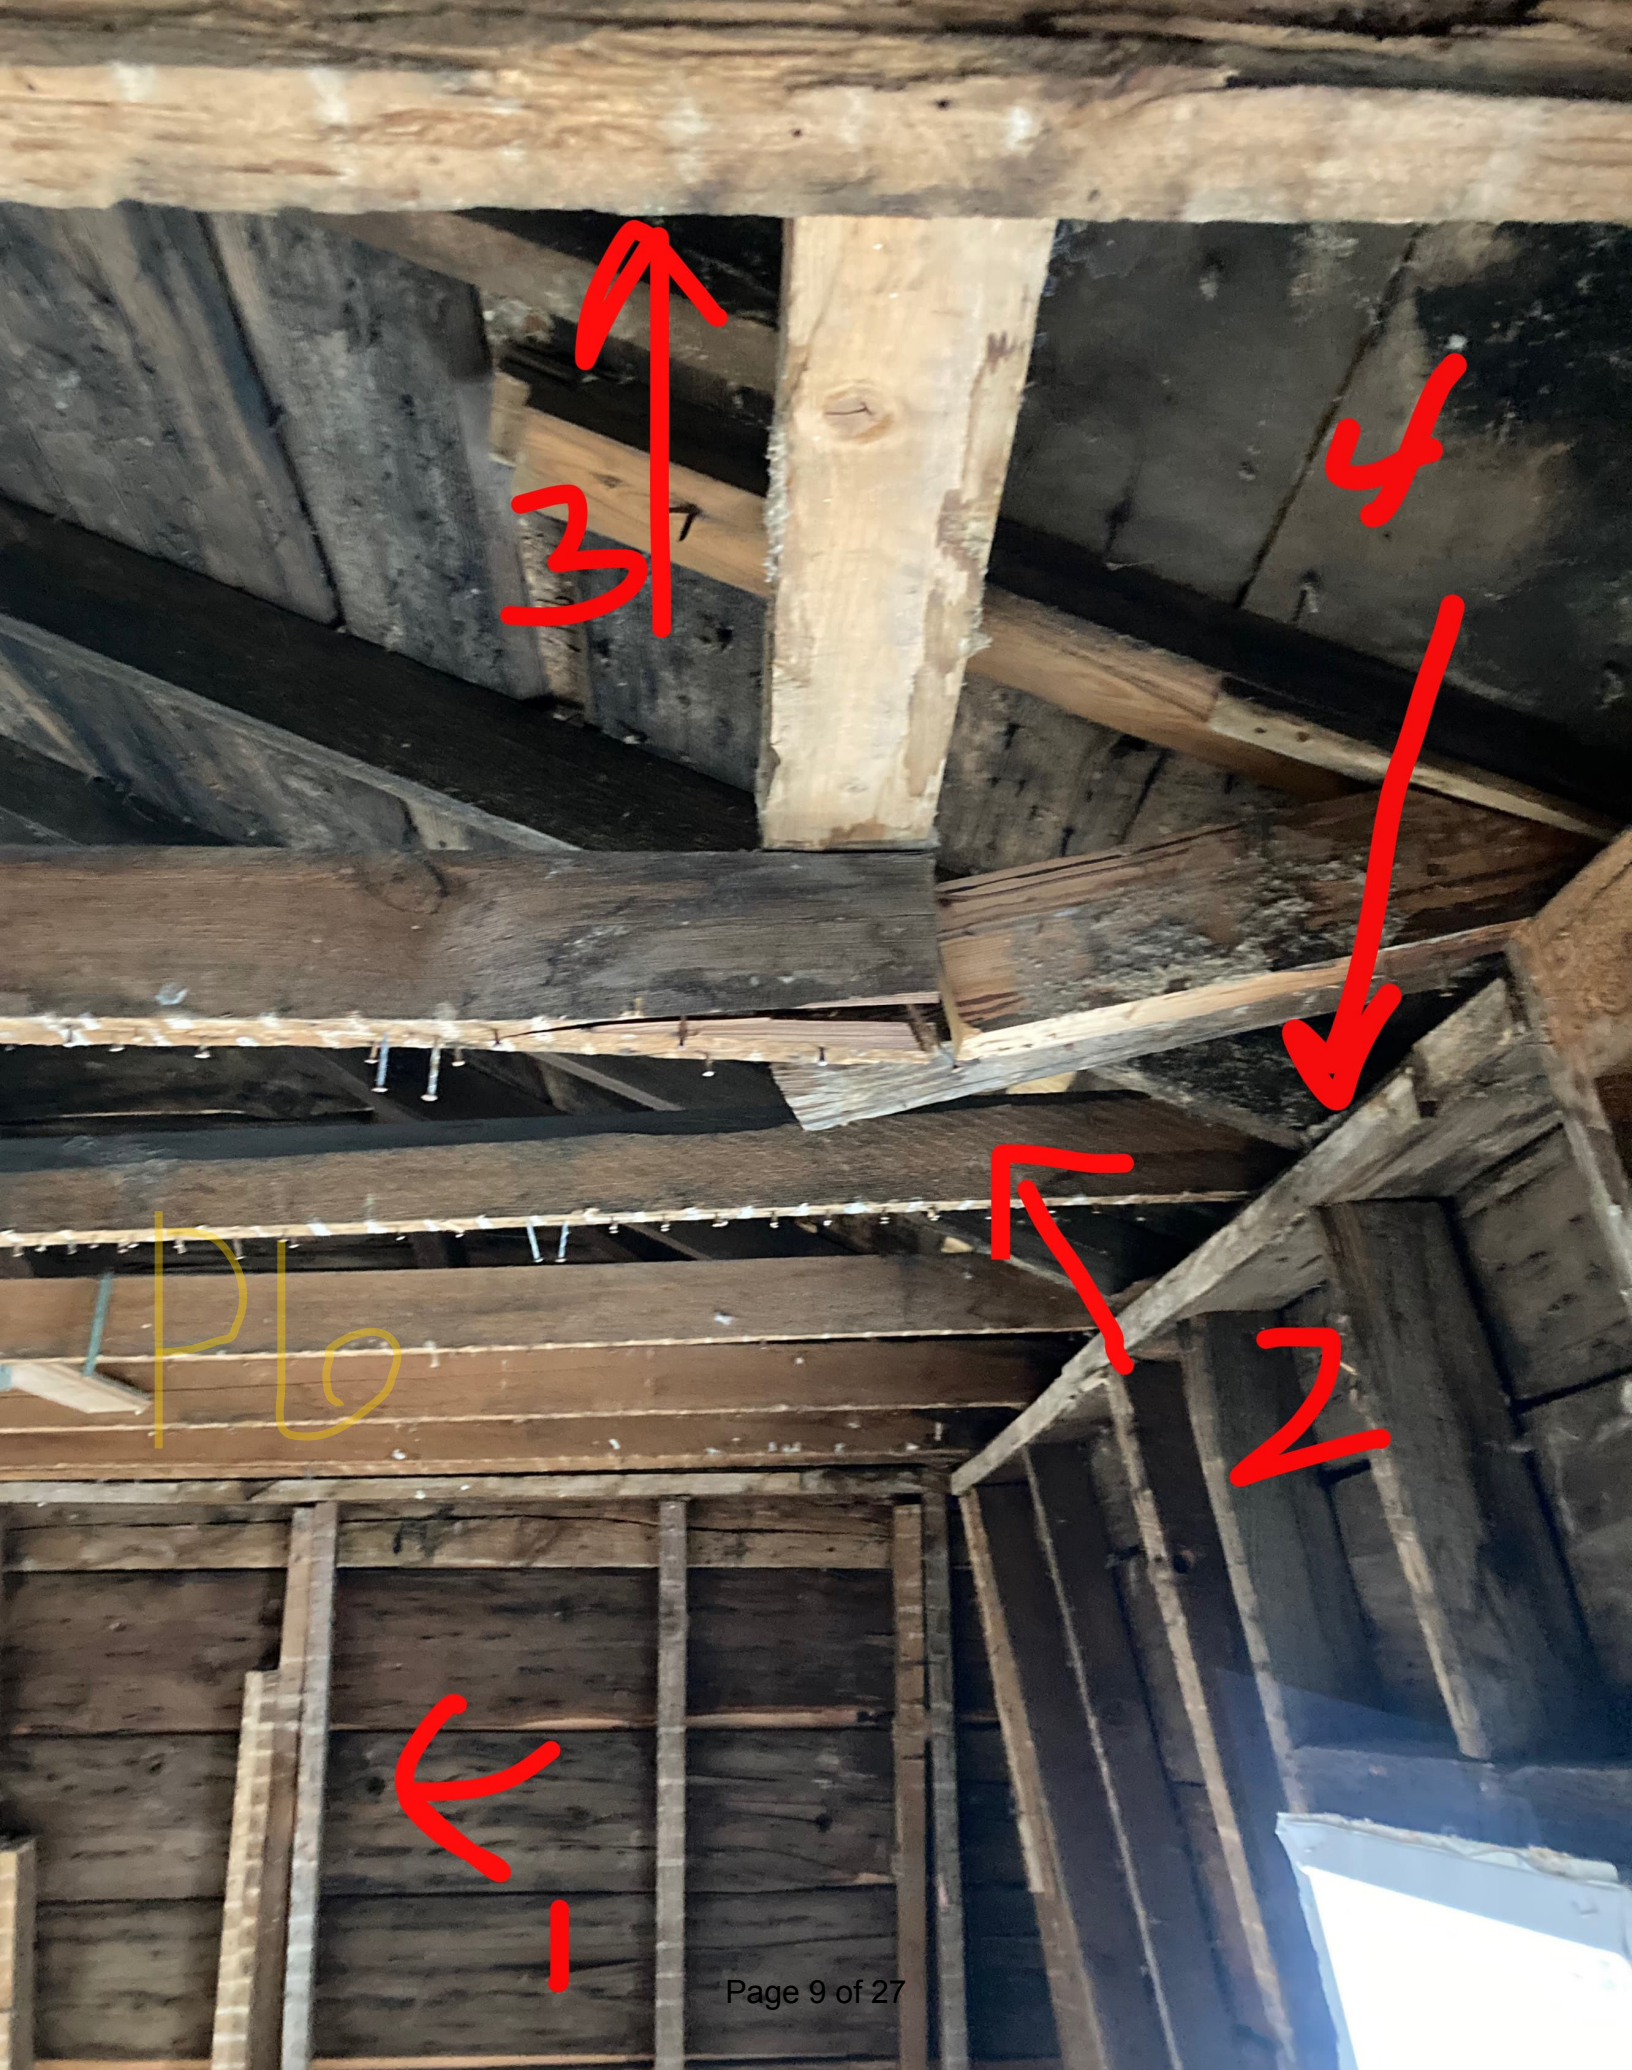
P5

3.1	Rotten newer sheathing
3.2	Spliced principal rafter with 1x4
3.3	Another spliced principal rafter with 1x4
3.4	Opposite view of spliced principal rafter
4	Broken principal rafter

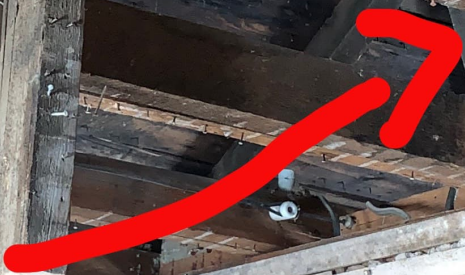
P8

6.1-6.4	Another view of ceiling and mansard rafters
7	Scabbed together ceiling joist with crack
8.1	Ceiling joist with water damage
8.2-8.3	Scissored ceiling joist, doesn't run entire ceiling width

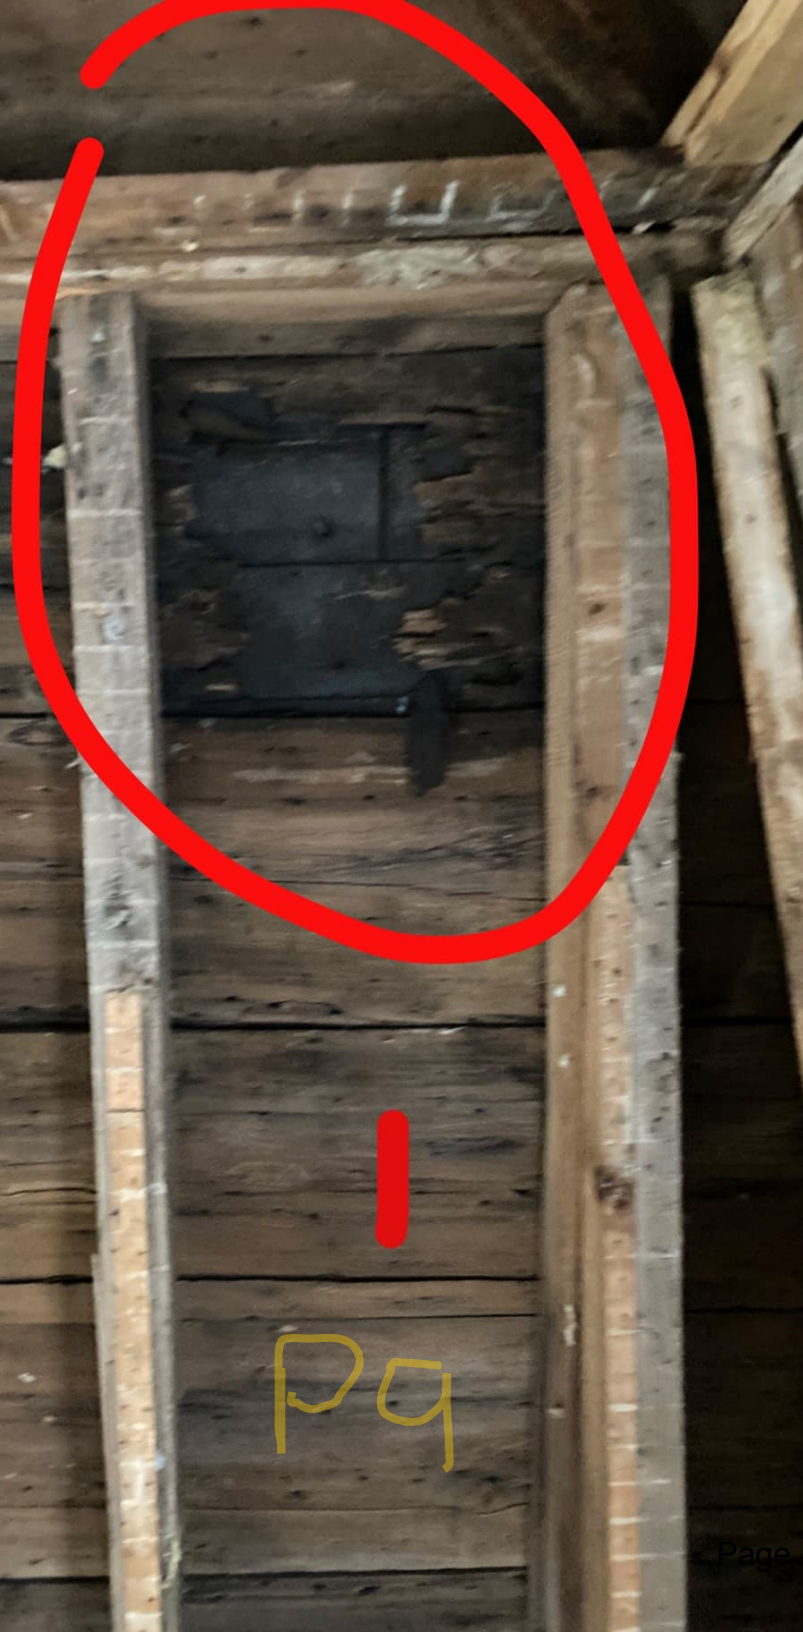
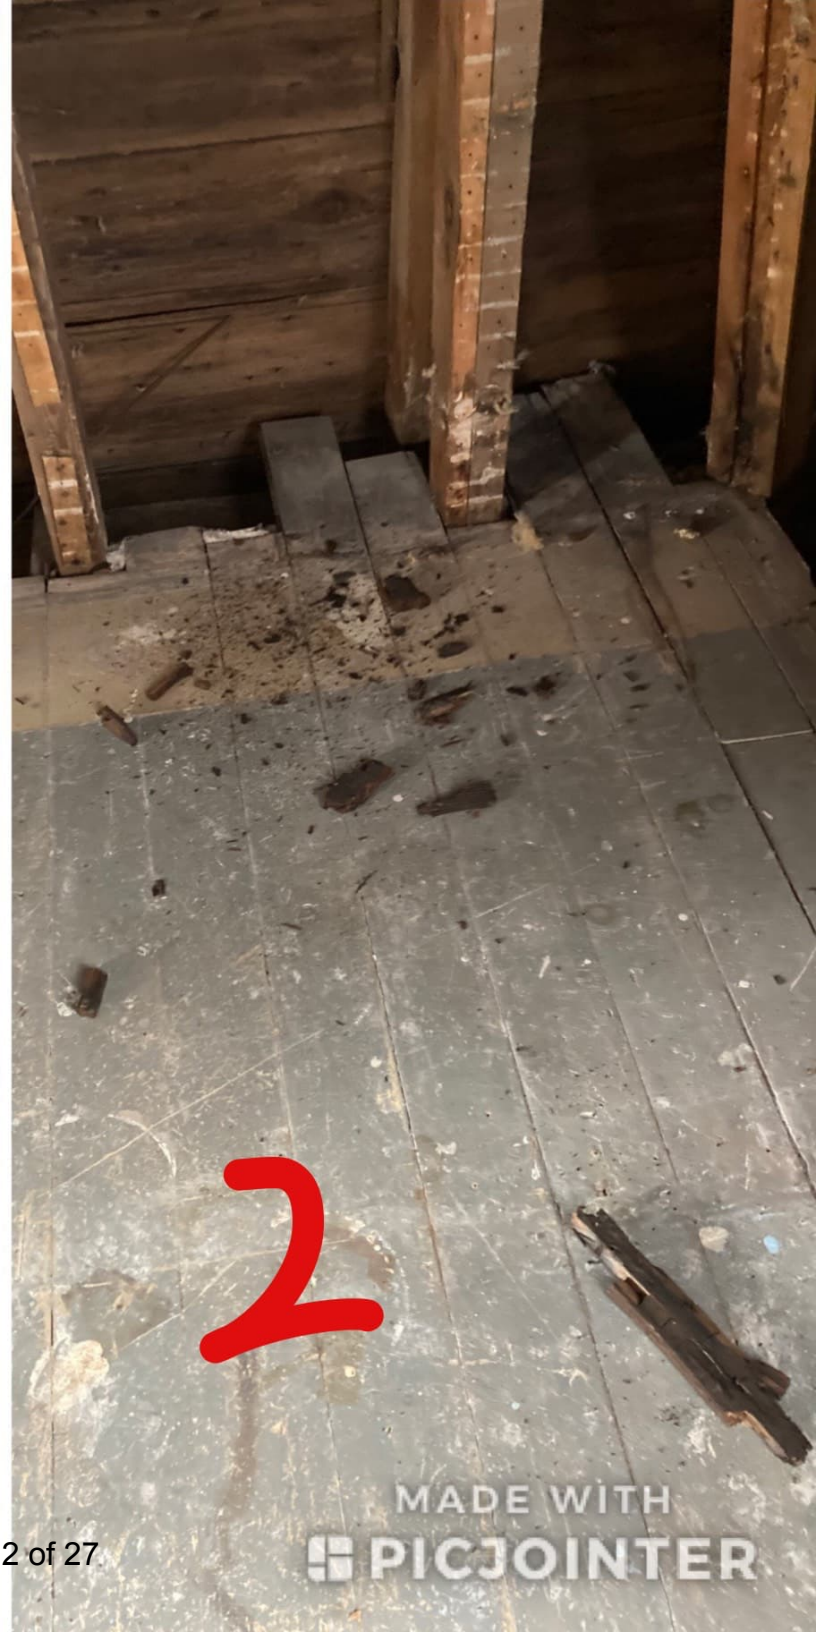
P10

9.1	Original sheathing on roof has wood rot and is falling apart, exposing shingles
9.2	Wall sheathing is crumbling on touch
10.1	Fire damage
10.2	Water damage and rot

10.3	Bearing wall has shifted and leans
10.4	Mansard rafters/walls scabbed together
11	Structural- Bearing wall had previous fire, both plates have been burned through and the ceiling joist

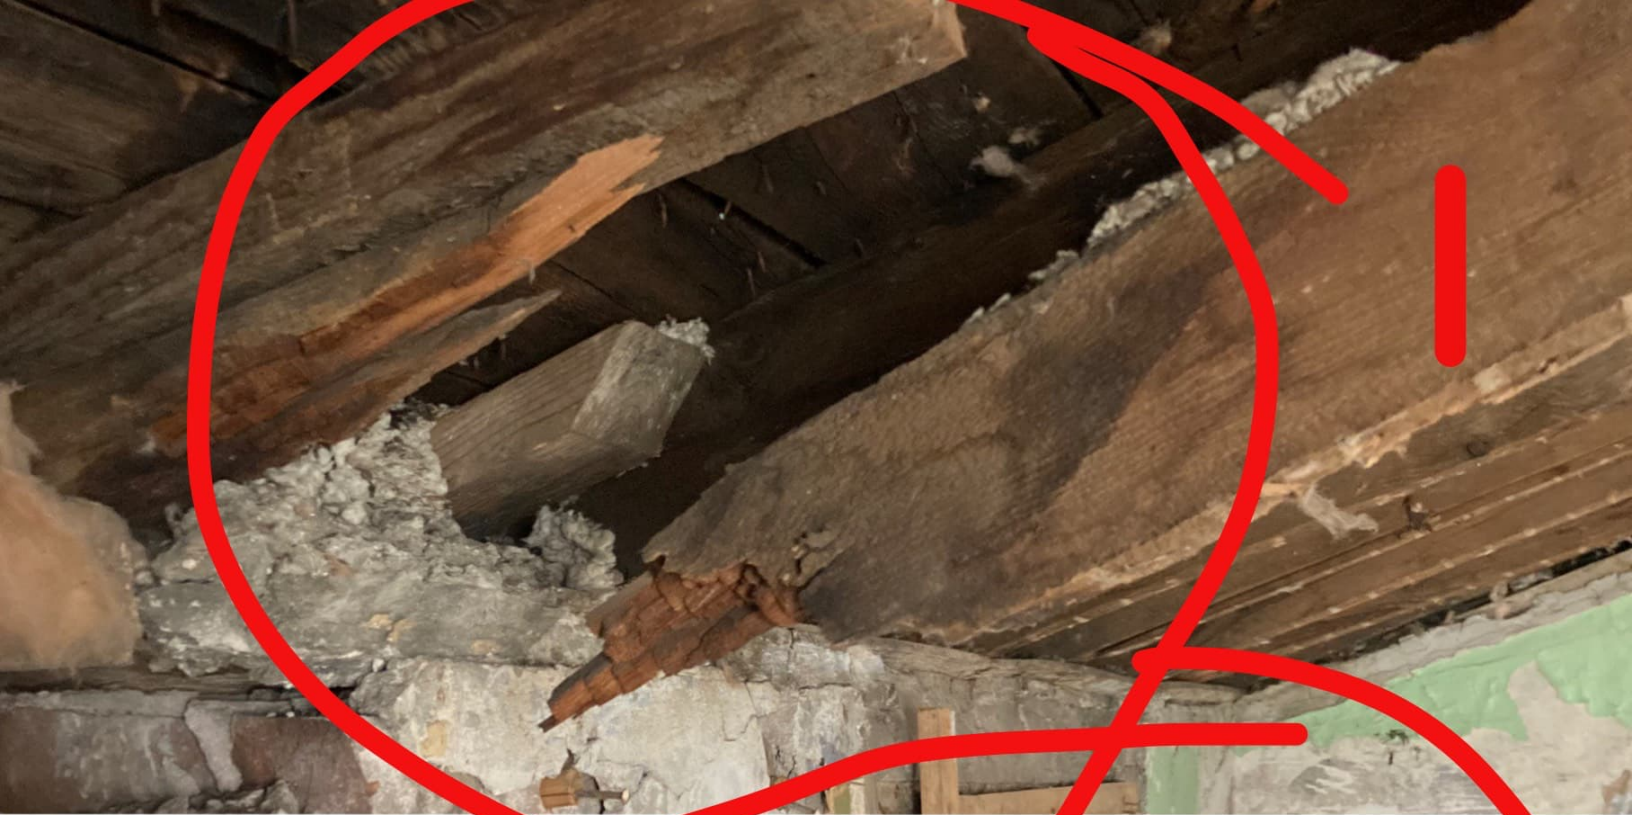
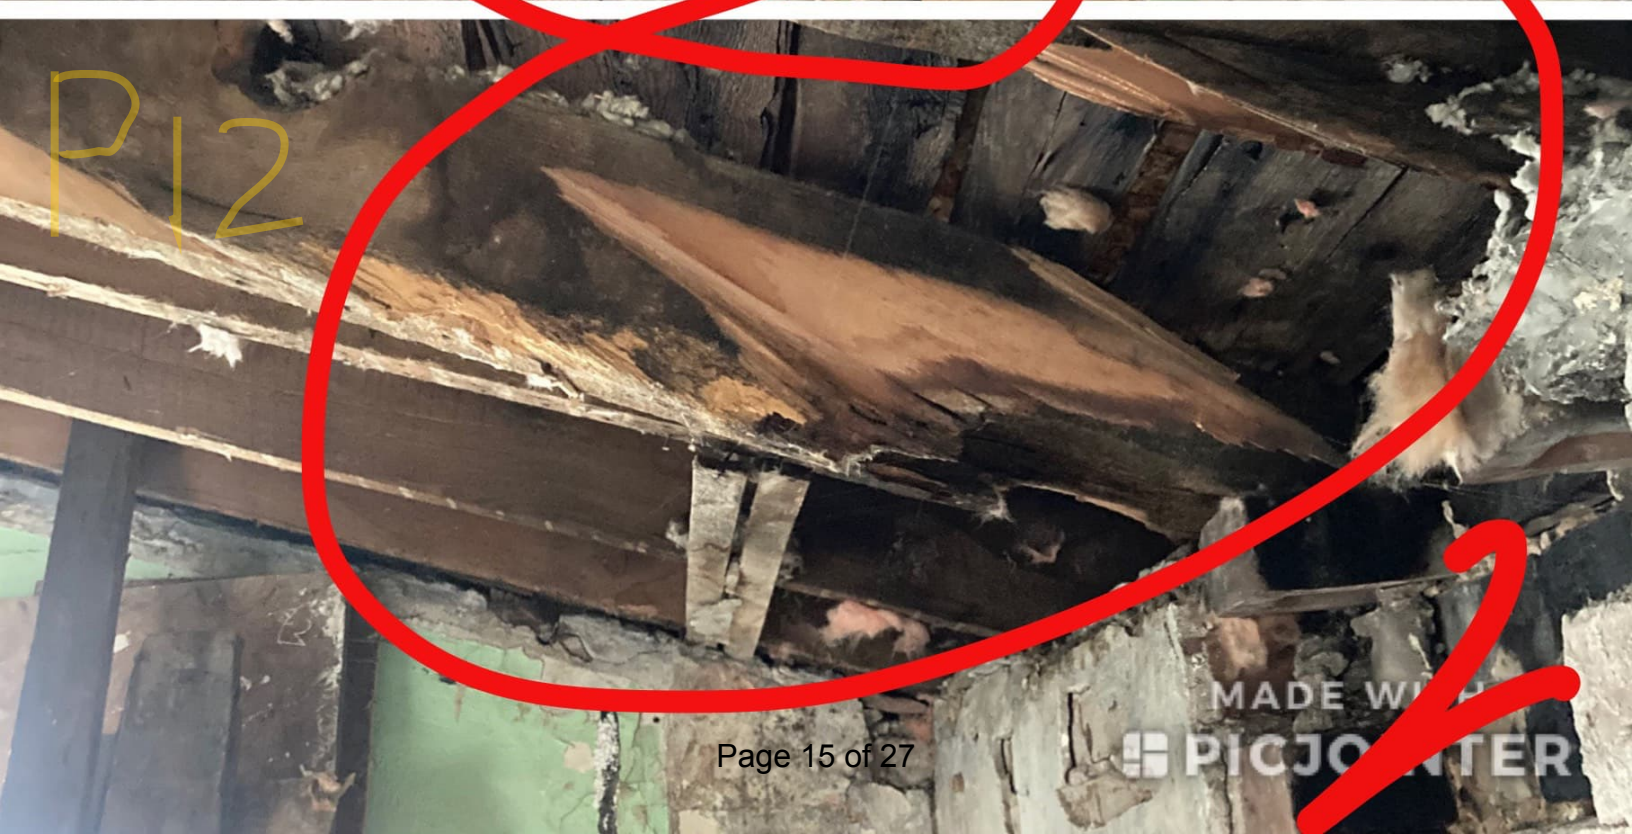
P13

12.1-12.2	2 different snapped principal rafters
13.1	Window has no lintel
13.2	Unsupported stud causing stairs to bounce
13.3	Floor joists for second floor are spliced together, don't run the entire length and are structurally not supported correctly causing upper floor to sag and bounce.
14	Floor joists cut and resting on a 2x2
15	Floor joist cut for plumbing causing weakness above, bouncing. And also water damage to second floor

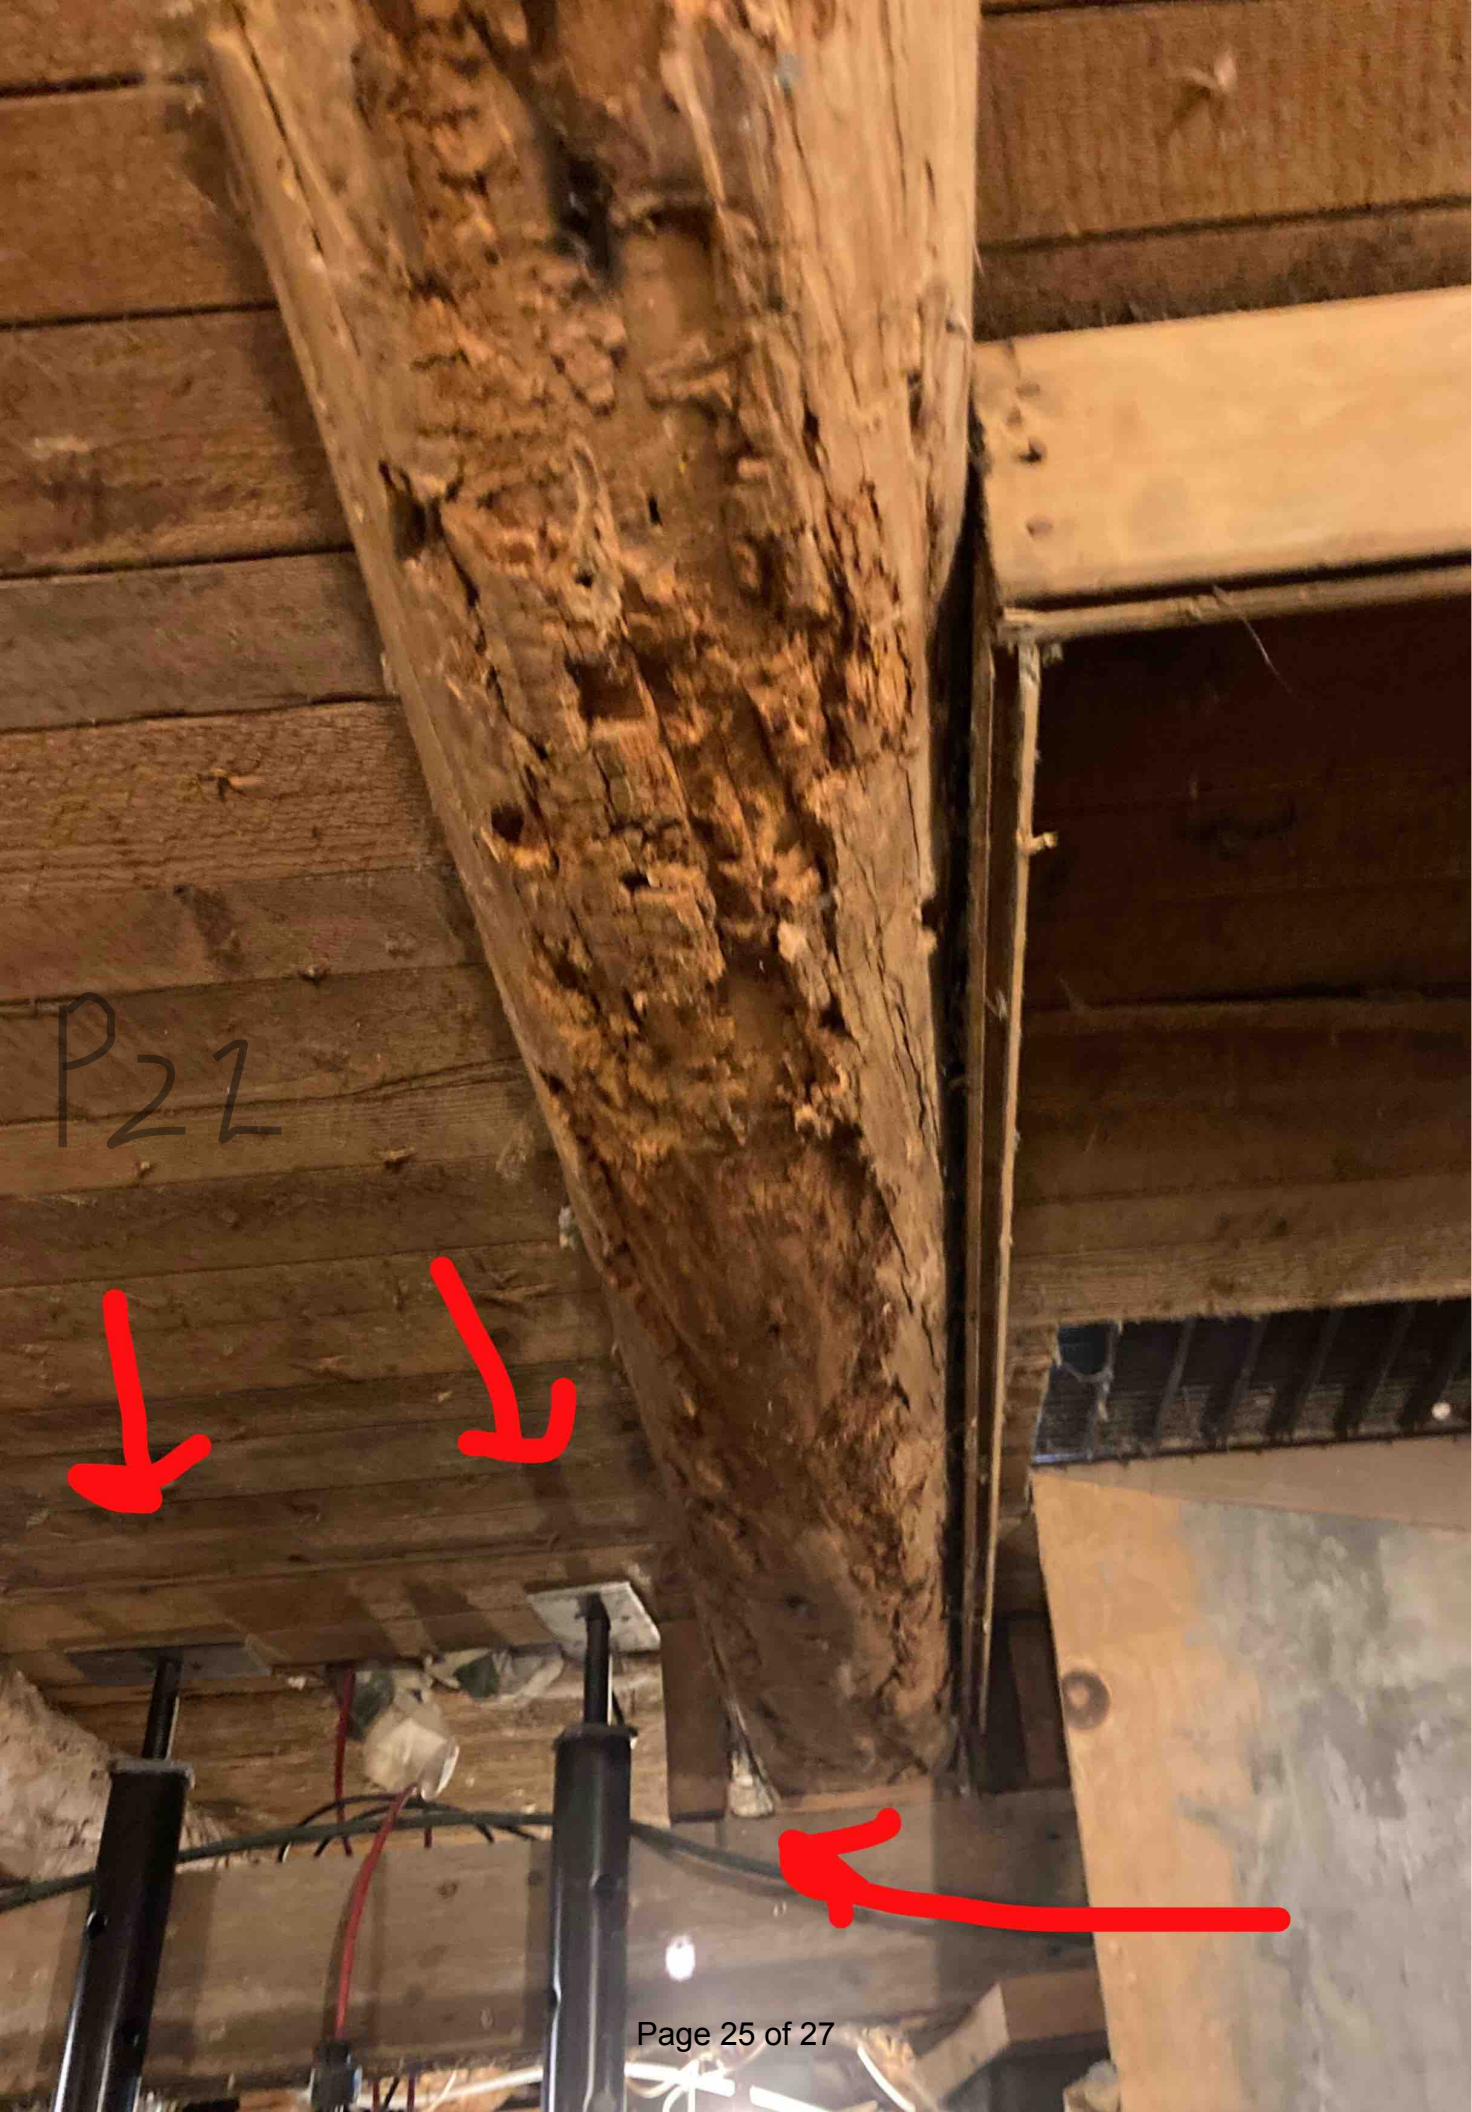
P21

19.1-19.3 -20	Floor joists on first floor (numbered) are made of logs and full of dry rot. Crumble to the touch.
21.1-21.2	Center weight bearing wall running up to second floor has sagged and is compromised as the main beam in the basement is not supported correctly and the support post has rot due to water
22	We added temporary jack posts as the main beam is crooked and not under the weight bearing wall on the 1 st floor that runs to the 2 nd floor (causing weight bearing wall on 2 nd floor to lean as the wall is not supported evenly).
