Heritage Orangeville Committee Meeting

Thursday, May 13, 2021, 7:00 p.m.

1. Call to Order
2. Disclosures of (Direct or Indirect) Pecuniary Interest
3. Adoption of Minutes of Previous Meeting - Not Applicable
4. Presentations
5. Items for Discussion and Reports
 - 5.1. Comments from Bruce Ewald, Chief Building Inspector - Demolition of Dwelling - 14 William Street
6. Facade Improvement Applications
7. Correspondence
8. New Business
9. Date of Next Meeting

14 William St Orangeville Demolition permit application:

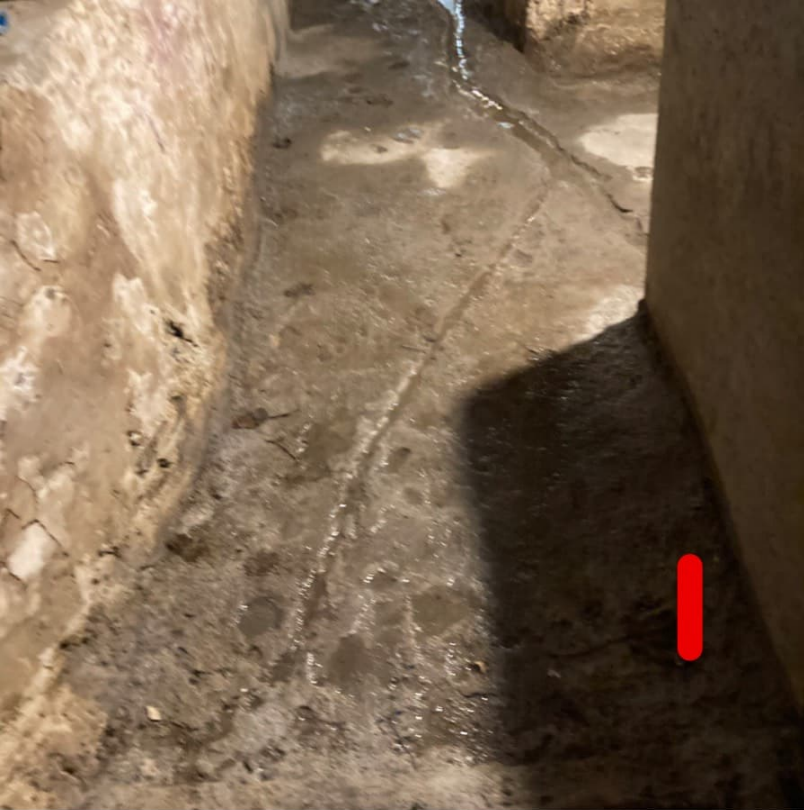
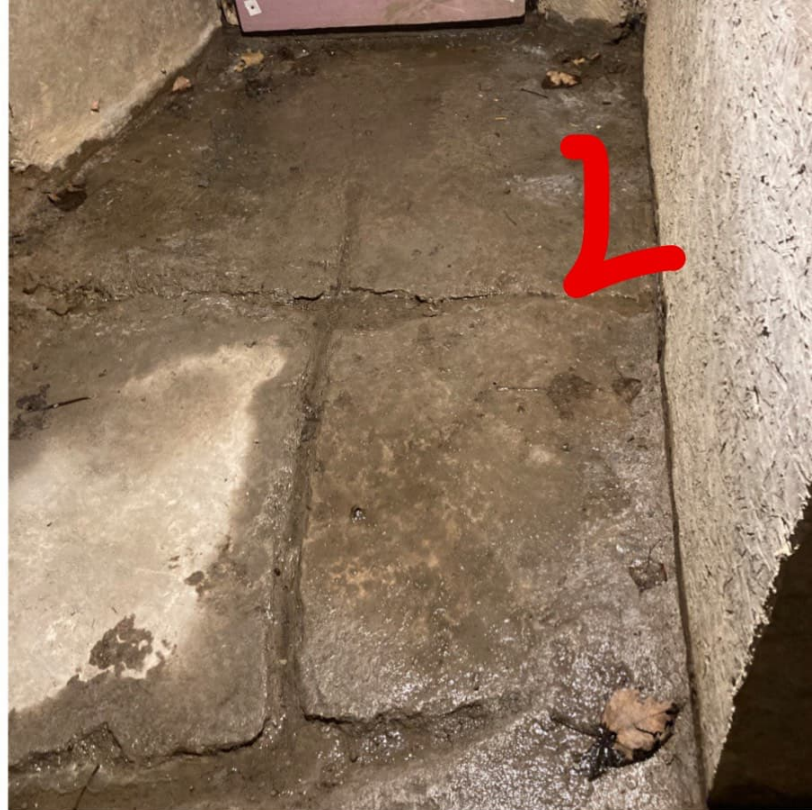
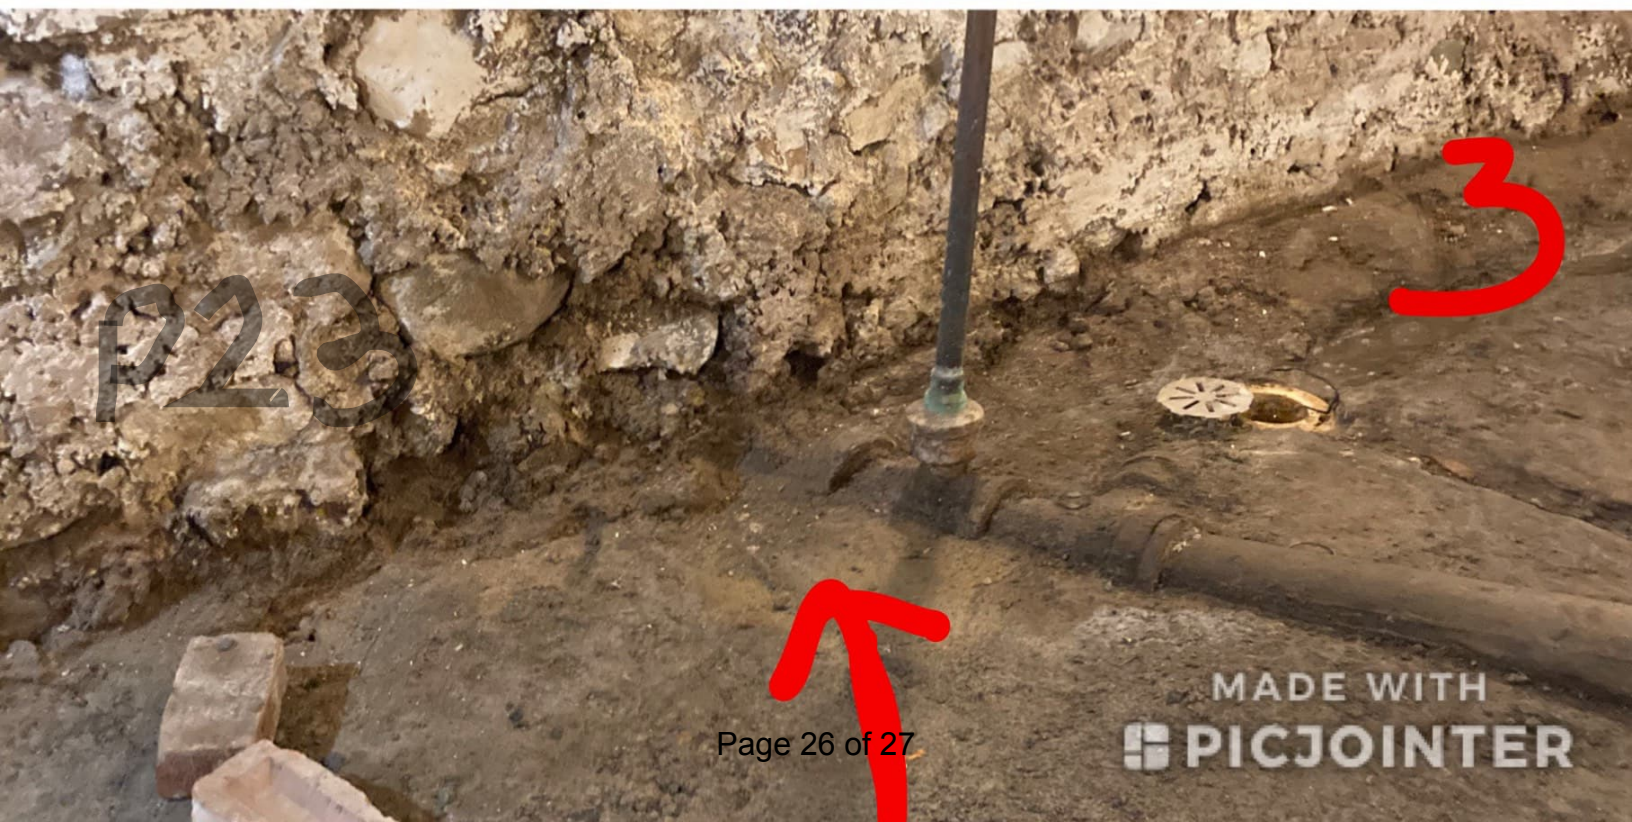
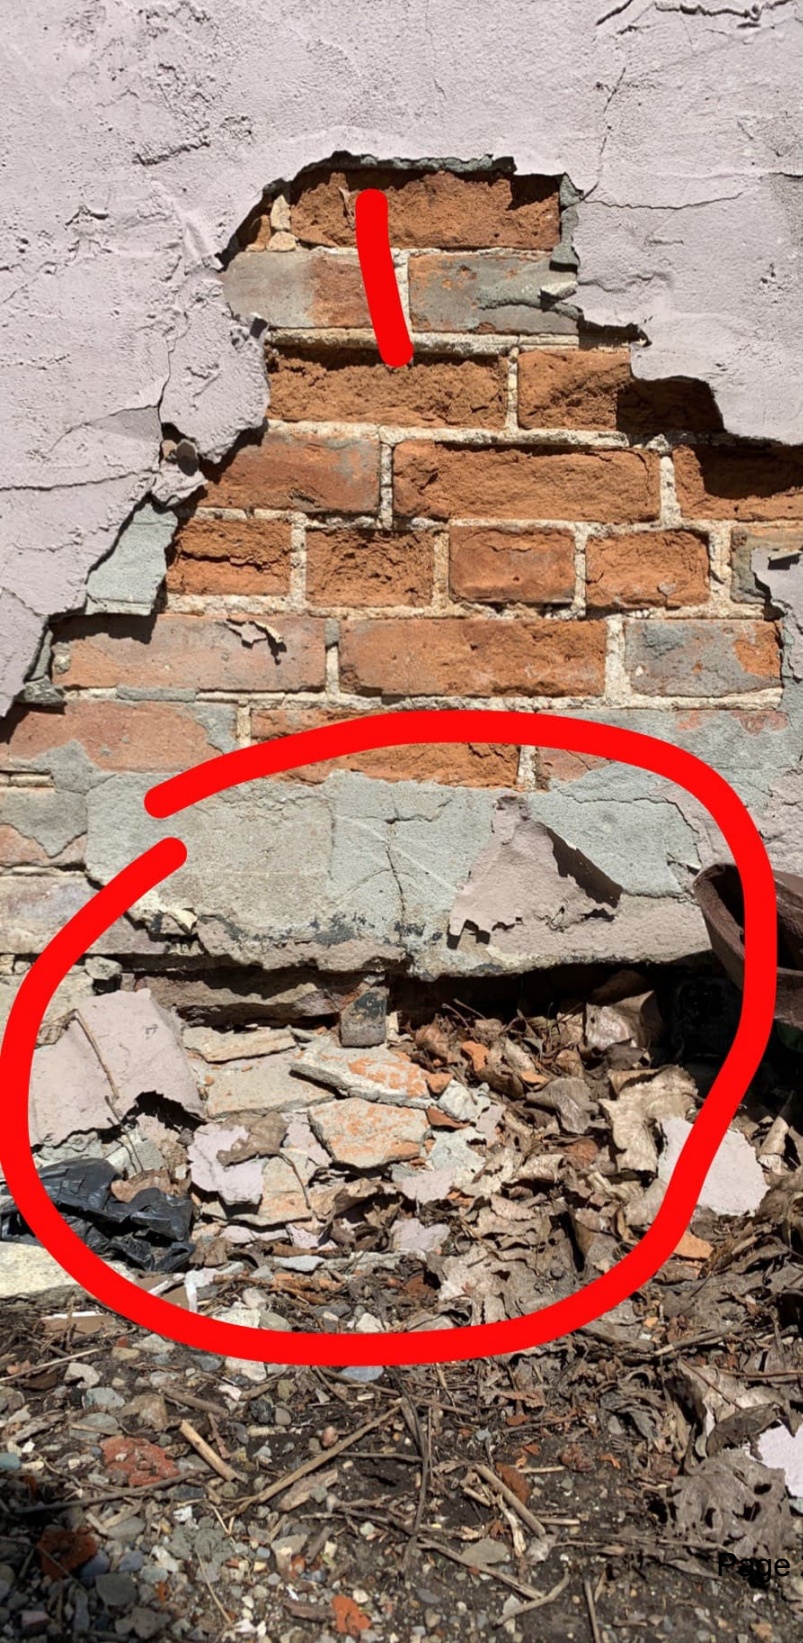
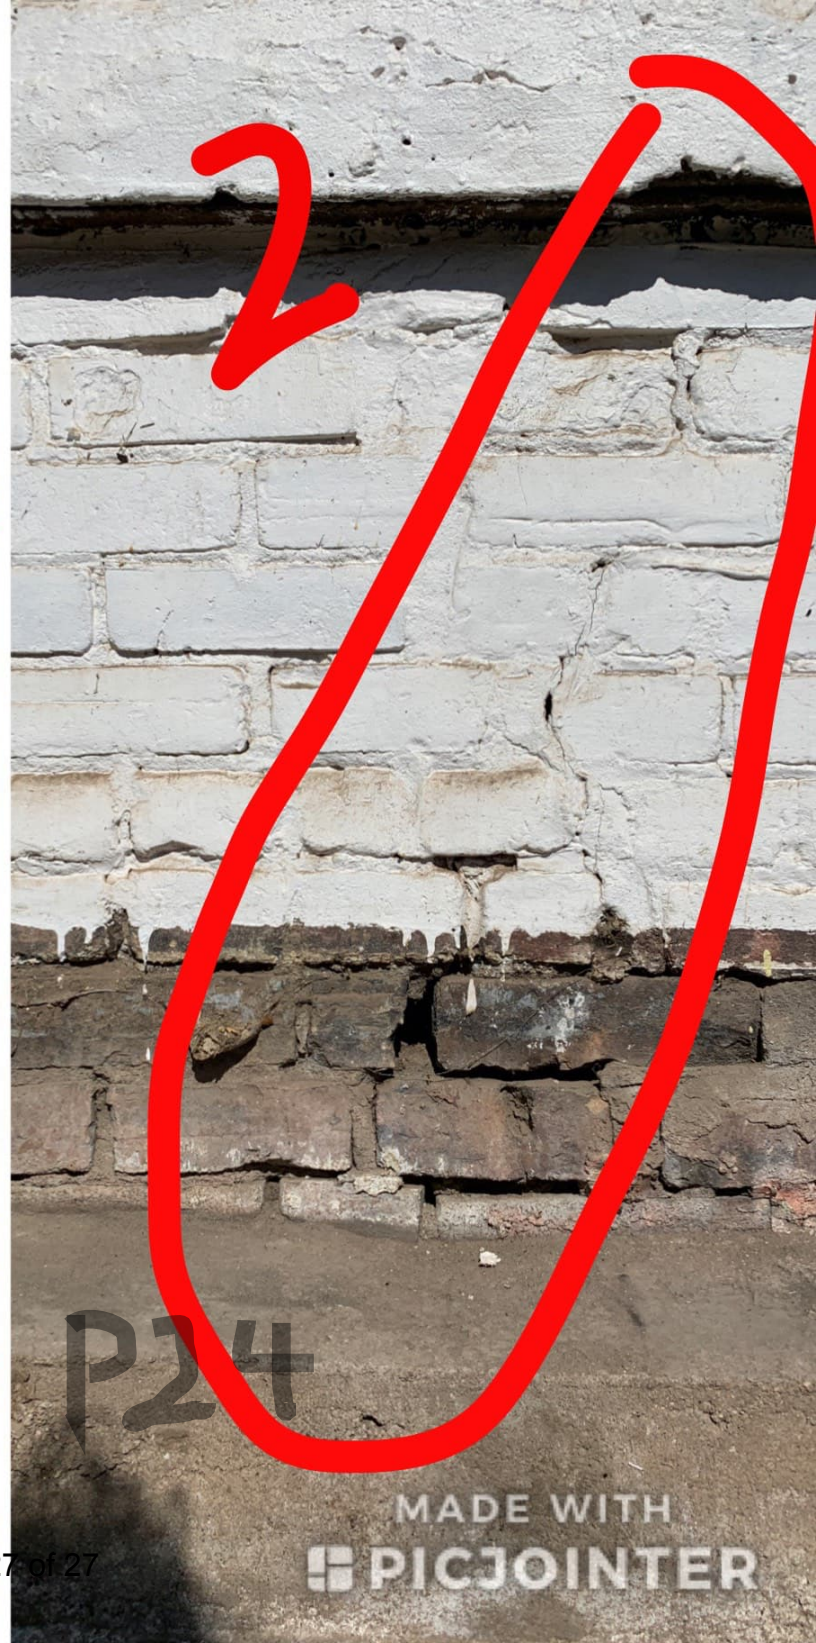
23.1-23.2	Basement floor seeps water up from the ground causing rot, damp, mold and rot
23.3	Cast drain in basement has been videoed and it is actually bent/crushing under the weight of the rubble foundation.

24.1	Structure is double brick but has been stuccoed. Where it is visible it is friable
24.2	Diagonal crack, shifting?
	<p>Elements for second empire replica</p> <p>Mansard roof, Dormers, Scalloped or dog eared roofing, Tall 2 over 2 windows</p> <p>Projecting Bay, Projecting raised porch entry, Posts, Cast iron cresting on porch roof</p> <p>Sided or bricked</p>
